DEPARTMENT OF TRANSPORTATION

Contract #: 04-0120F4Cty: SF/ALA Rte: 80 PM: 13.2/13.9File #: 1.28**WELDING INSPECTION REPORT****Resident Engineer:** Casey, William**Address:** 333 Burma Road**City:** Oakland, CA 94607**Report No:** WIR-028276**Date Inspected:** 28-Aug-2012**Project Name:** SAS Superstructure**OSM Arrival Time:** 700**Prime Contractor:** American Bridge/Fluor Enterprises, a JV**OSM Departure Time:** 1930**Contractor:** American Bridge/Fluor Enterprises, a JV**Location:** Job Site**CWI Name:** See below.**CWI Present:** Yes No**Inspected CWI report:** Yes No N/A**Rod Oven in Use:** Yes No N/A**Electrode to specification:** Yes No N/A**Weld Procedures Followed:** Yes No N/A**Qualified Welders:** Yes No N/A**Verified Joint Fit-up:** Yes No N/A**Approved Drawings:** Yes No N/A**Approved WPS:** Yes No N/A**Delayed / Cancelled:** Yes No N/A**Bridge No:** 34-0006**Component:** OBG**Summary of Items Observed:**

OBG 13E

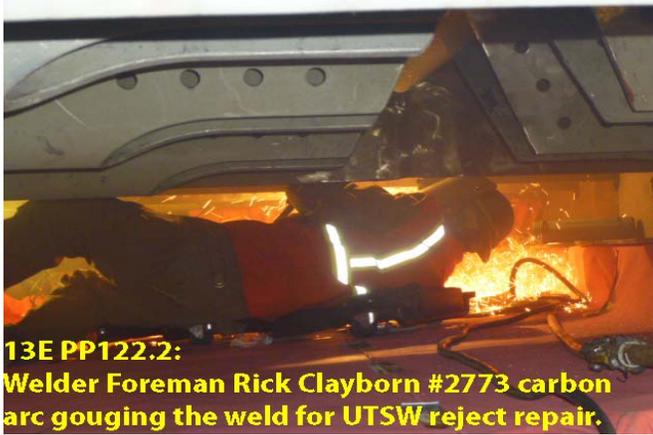
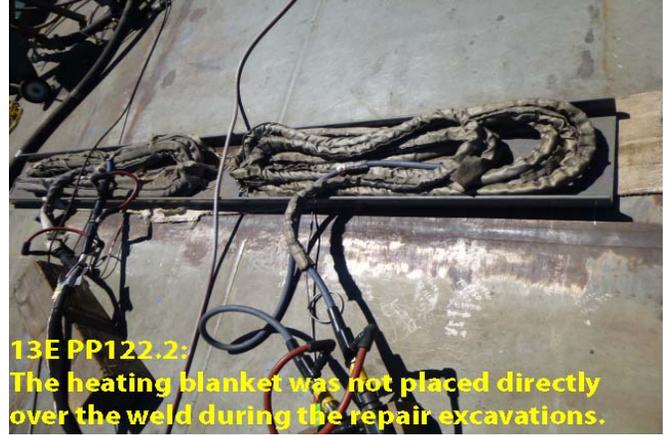
Welder Foreman Rick Clayborn was observed performing weld repairs excavations on Ultrasonic Testing Shear Wave rejects (UTSW) noted on weld 13E PP122.2. During the carbon arc gouge (CAG) this QA noted the pre-heat temperature for the carbon arc gouge had not been attained by the heat blanket placed on the weld. Upon closer inspection of the heat blanket it was noted the blanket was not proper placed to cover the weld. This QA informed the welder of the nonconformance and the welder immediately made corrections for the pre-heat and continued with the excavations. This QA verified the pre-heat temperature of over 230 degrees Fahrenheit after the blanket was repositioned for the carbon arc gouge of repairs.
