**DEPARTMENT OF TRANSPORTATION**

Contract #: 04-0120F4Cty: SF/ALA Rte: 80 PM: 13.2/13.9File #: 1.28**WELDING INSPECTION REPORT****Resident Engineer:** Casey, William**Address:** 333 Burma Road**City:** Oakland, CA 94607**Report No:** WIR-028279**Date Inspected:** 27-Aug-2012**Project Name:** SAS Superstructure**OSM Arrival Time:** 700**Prime Contractor:** American Bridge/Fluor Enterprises, a JV**OSM Departure Time:** 1930**Contractor:** American Bridge/Fluor Enterprises, a JV**Location:** jobsite**CWI Name:** Pat Swain**CWI Present:** Yes No**Inspected CWI report:** Yes No N/A**Rod Oven in Use:** Yes No N/A**Electrode to specification:** Yes No N/A**Weld Procedures Followed:** Yes No N/A**Qualified Welders:** Yes No N/A**Verified Joint Fit-up:** Yes No N/A**Approved Drawings:** Yes No N/A**Approved WPS:** Yes No N/A**Delayed / Cancelled:** Yes No N/A**Bridge No:** 34-0006**Component:** OBG**Summary of Items Observed:**

1. Weld Repair 12/13W-C1 Y=1090

2. Weld Repair of grinding divots 12W-PP111.1-C1

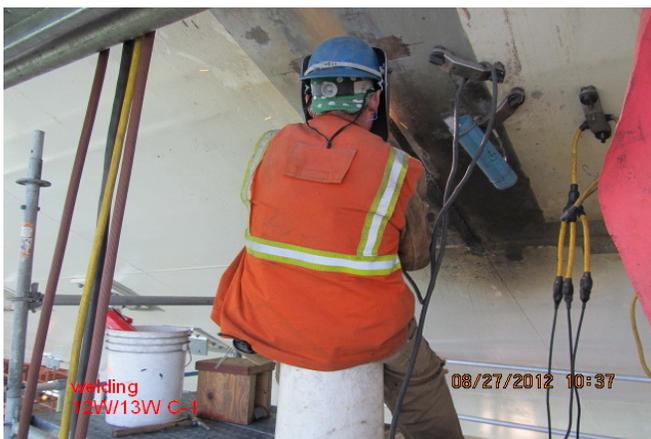
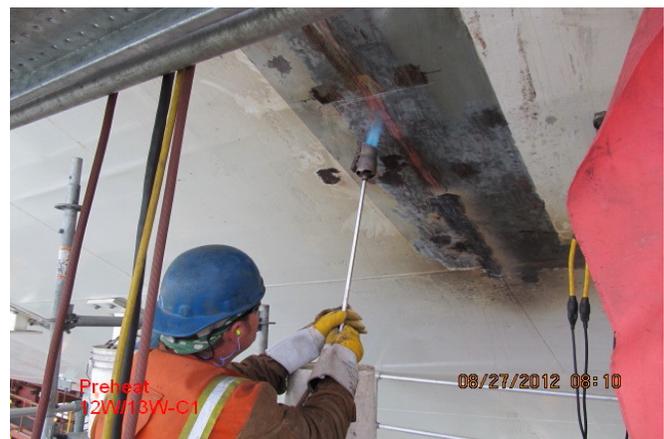
The QA inspector monitored the critical weld repair being performed by ABF welding personnel Rick Clayborn on grinding divots of Splice 12W PP111.1 C1. The divots were at various locations along the splice.

The welder spent the majority of time depositing the root passes, fill passes, and cap passes with approximately 100% being completed at the end of the shift. QC inspector Pat Swain was noted to be present in order to monitor the progress and ensure the welding was within the established Welding Procedure Specification (WPS) noted as ABF-WPS-D15-1004R and supporting Procedure Qualification Records (PQR). Prior to initiating the welding at this location the QC inspector observed the preheat temperature and using a Raytek non-contact Thermometer, was sufficient and compliant to the above-mentioned WPS. Using a Tempil Stick, (temperature indicating crayon) the preheat, temperature was then verified by this QA inspector to be greater than 350F. The parameters, using a Fluke brand Tong style meter, were verified to be 160 amps. At the conclusion of welding operations Mr Clayburn post heated at a QC recorded QA verified temperature of 450F for one hour.
