DEPARTMENT OF TRANSPORTATION

Contract #: 04-0120F4Cty: SF/ALA Rte: 80 PM: 13.2/13.9File #: 1.28**WELDING INSPECTION REPORT****Resident Engineer:** Casey, William**Address:** 333 Burma Road**City:** Oakland, CA 94607**Report No:** WIR-028289**Date Inspected:** 30-Aug-2012**Project Name:** SAS Superstructure**OSM Arrival Time:** 700**Prime Contractor:** American Bridge/Fluor Enterprises, a JV**OSM Departure Time:** 1930**Contractor:** American Bridge/Fluor Enterprises, a JV**Location:** Job Site**CWI Name:** Barry Drake**CWI Present:** Yes No**Inspected CWI report:** Yes No N/A**Rod Oven in Use:** Yes No N/A**Electrode to specification:** Yes No N/A**Weld Procedures Followed:** Yes No N/A**Qualified Welders:** Yes No N/A**Verified Joint Fit-up:** Yes No N/A**Approved Drawings:** Yes No N/A**Approved WPS:** Yes No N/A**Delayed / Cancelled:** Yes No N/A**Bridge No:** 34-0006**Component:** SAS OBG**Summary of Items Observed:**

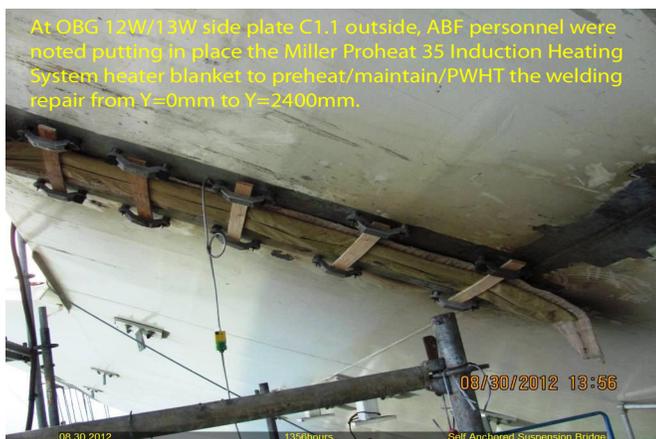
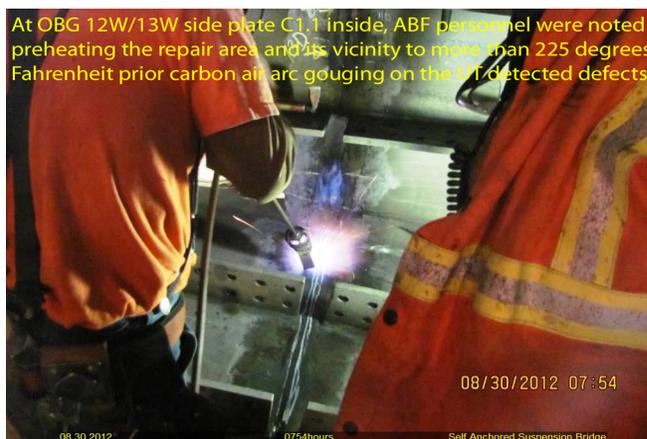
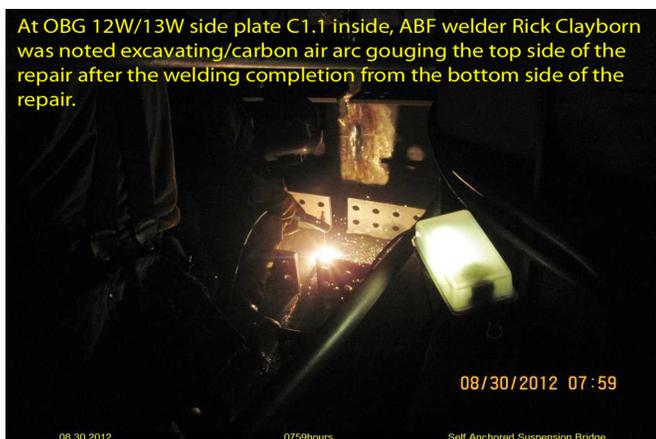
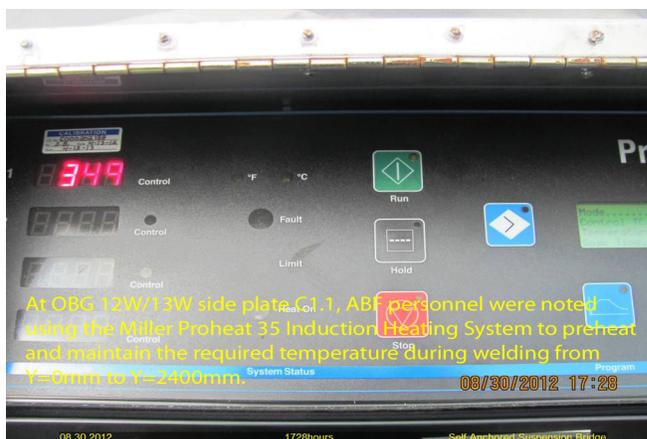
At OBG 12W/13W side plate C1.1 outside, QA randomly observed ABF/JV qualified welder Rick Clayborn continuing to perform CJP groove welding repair on a Seismic Performance Critical Member (SPCM) welded splice butt joint. After completing the repair on the bottom side of the welded splice butt joint, the welder has started excavating/carbon air arc gouging the whole length of the top side of the same weld joint. The welder was noted preheating the weld joint repair from the inside using propylene gas torch at more than 225°F prior the excavation. The excavation on the top whole length of 2400mm was completed and the groove was noted ground smooth by Mike Jimenez. ABF QC Pat Swain was noted performing visual test (VT) on the excavation and then performed Magnetic Particle Testing (MT) with no relevant indication noted during the test. This QA performed the same tests VT/MT and noted same results.

ABF foreman Rick Clayborn instructed other personnel to preheat the weld joint repair from the outside using the same propylene gas torch. Two ABF personnel were noted at the bottom of the weld joint repair (outside) preheating the bottom of the repair. The two personnel were also noted moving the torches from side to side of the weld joint repair and tried to distribute the heat evenly with some degree of difficulty maintaining the required 325°F preheat. ABF welders Rick Clayborn and Mike Jimenez were observed 3G SMAW welding repair on the top of the repair where the preheat was more than 325°F. Due to this situation, this QA informed ABF Superintendent Scott Smith that his personnel were having difficulty maintaining the preheat much more when

they perform the 450°F Post Weld Heat Treatment (PWHT) on the same repair. Mr. Smith responded to this QA that he will talk to the foreman Rick Clayborn to discuss the situation. After Mr. Smith's discussion with Rick Clayborn, it was later learned that ABF will use the Miller Proheat 35 Induction Heating System to preheat the repair welding. While trying to gather the Miller Proheat machine and its accessories, two (2) ABF personnel were noted preheating the weld repair area using two propylene gas torches in tandem trying to maintain the preheat temperature. Minutes later, the heating system was switched to Miller Proheat 35 Induction System.

As soon as the preheat of 325°F was attained using the Miller Proheat 35, ABF welders Mike Jimenez and Rick Clayborn were observed performing 3G (vertical) position Shielded Metal Arc Welding (SMAW) welding repair on welded splice butt joint. The welders were noted using 4.0mm E7018H4R electrode implementing Caltrans approved welding procedure ABF-WPS-D15-1004 Repair. ABF QC Barry Drake was noted monitoring the welders with measured working current of 180 amperes and 178 amperes respectively for Mike Jimenez and Rick Clayborn. ABF welder Rick Clayborn left at noon while Mike Jimenez continued 3G SMAW repair welding till the end of shift wherein he was not able to complete the repair. Repair welding will continue tomorrow.
