Quality Assurance and Source Inspection

Contract #: 04-0120F4Cty: SF/ALA Rte: 80 PM: 13.2/13.9File #: 1.28**WELDING INSPECTION REPORT**

Report No: WIR-028292
Date Inspected: 28-Aug-2012

Project Name: SAS Superstructure
Prime Contractor: American Bridge/Fluor Enterprises, a JV
Contractor: American Bridge/Fluor Enterprises, a JV

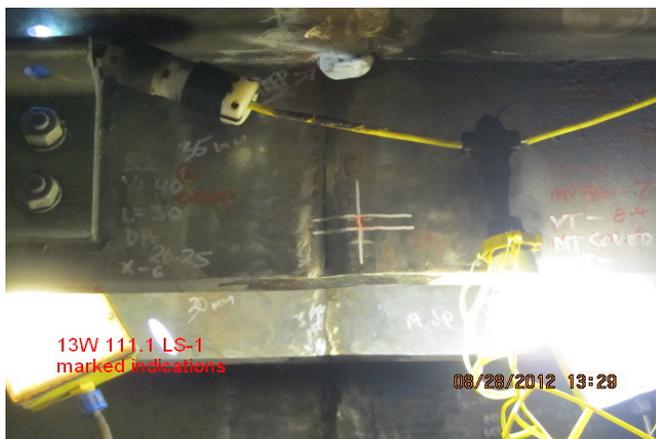
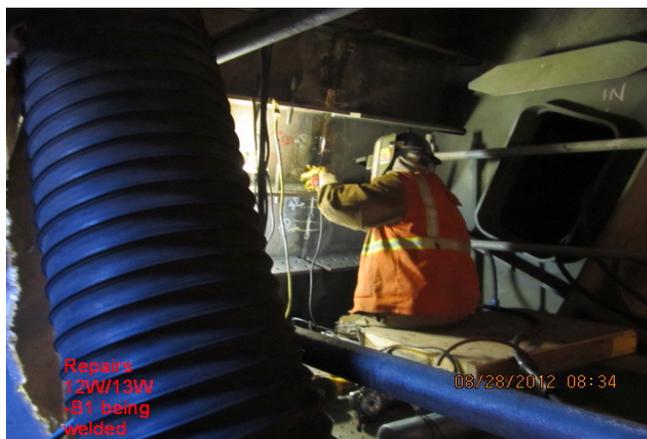
This QA Inspector observed Eric Sparks pre-heating to a QA verified temperature of 250F prior to using the Carbon Arc Gouging process to remove defects on the above-mentioned Longitudinal Stiffener. The locations and depth of the defects had been marked on the steel by the Ultrasonic Technician at the conclusion of his testing. At the end of gouging operations Mr. Sparks ground the excavations to a bright clean metal condition in preparation of Visual and Magnetic Particle Testing.

above excavations. This Quality Assurance Inspector verified the results of the test by doing duplicate testing to the excavations. No indications were noted. No welding was performed to the repairs.
