DEPARTMENT OF TRANSPORTATION

Contract #: 04-0120F4Cty: SF/ALA Rte: 80 PM: 13.2/13.9File #: 1.28**WELDING INSPECTION REPORT****Resident Engineer:** Casey, William**Address:** 333 Burma Road**City:** Oakland, CA 94607**Report No:** WIR-028326**Date Inspected:** 04-Sep-2012**Project Name:** SAS Superstructure**OSM Arrival Time:** 700**Prime Contractor:** American Bridge/Fluor Enterprises, a JV**OSM Departure Time:** 1900**Contractor:** American Bridge/Fluor Enterprises, a JV**Location:** jobsite**CWI Name:** Scott Kortum**CWI Present:** Yes No**Inspected CWI report:** Yes No N/A**Rod Oven in Use:** Yes No N/A**Electrode to specification:** Yes No N/A**Weld Procedures Followed:** Yes No N/A**Qualified Welders:** Yes No N/A**Verified Joint Fit-up:** Yes No N/A**Approved Drawings:** Yes No N/A**Approved WPS:** Yes No N/A**Delayed / Cancelled:** Yes No N/A**Bridge No:** 34-0006**Component:** OBG**Summary of Items Observed:**

Weld Repairs 13W-PP122.5-W2.8 Y location 380mm

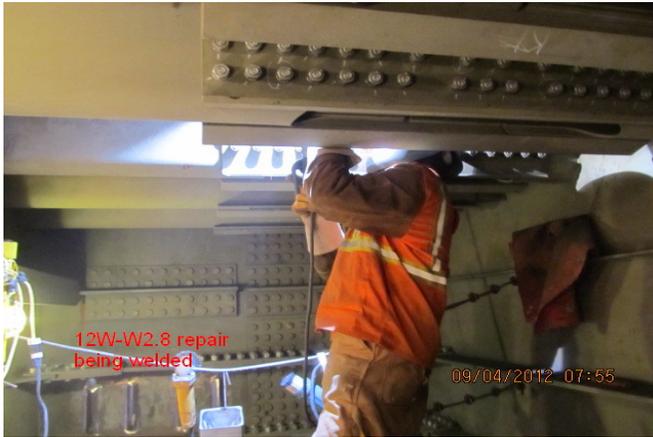
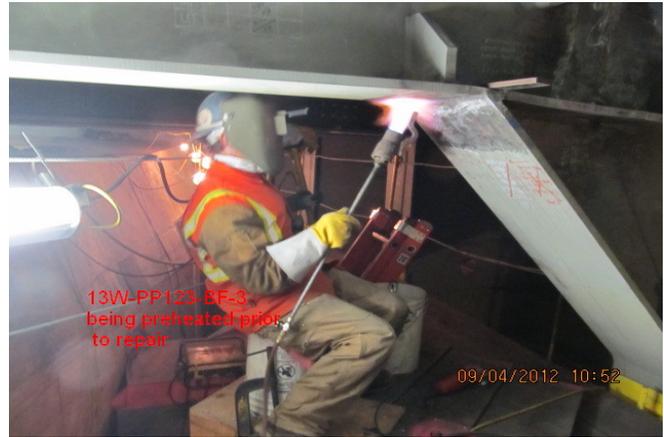
The QA inspector observed first time repair being performed by ABF welding personnel Lin E Yu (9344) on Deck Splice Weld 12W-W2.8, at the following location:

This QA Inspector observed Mr. Yu preheating to a QC recorded, QA verified temperature of 250F prior to using the Carbon Arc Gouging process to remove defects at the above-mentioned locations on the Deck Splice Weld. The locations and depth of the defects had been marked on the steel by the Ultrasonic Technician at the conclusion

Prior to welding Quality Control Technician Scott Kortum performed Visual and Magnetic Particle Testing on the above excavations. This Quality Assurance Inspector verified the results of the test by doing duplicate testing to the excavations. No indications were noted.

This QAI observed the welder Jimmy Zen grinding to a bright clean metal condition an excavation at the following location on Floor Beam Bottom Flange Splice 13W-PP123-BF-3:

This QAI observed the grinding at a 3:1 ratio of the above-mentioned remains of 13W-PP121.25-W3 Lifting Lug Bracket. The remains are being ground or faired to a 3:1 slope to accommodate design criteria. The personnel involved are using 8" angle grinders to achieve the above mention requirements. At the conclusion of grinding the area is tested using Magnetic Particle Testing and Visual Testing to check for any base metal or weld metal

fracturing. No areas were ready for inspection or testing on this day.
