DEPARTMENT OF TRANSPORTATION

Contract #: 04-0120F4Cty: SF/ALA Rte: 80 PM: 13.2/13.9File #: 1.28**WELDING INSPECTION REPORT****Resident Engineer:** Casey, William**Address:** 333 Burma Road**City:** Oakland, CA 94607**Report No:** WIR-028327**Date Inspected:** 06-Sep-2012**Project Name:** SAS Superstructure**OSM Arrival Time:** 700**Prime Contractor:** American Bridge/Fluor Enterprises, a JV**OSM Departure Time:** 2130**Contractor:** American Bridge/Fluor Enterprises, a JV**Location:** Job Site**CWI Name:** Barry Drake**CWI Present:** Yes No**Inspected CWI report:** Yes No N/A**Rod Oven in Use:** Yes No N/A**Electrode to specification:** Yes No N/A**Weld Procedures Followed:** Yes No N/A**Qualified Welders:** Yes No N/A**Verified Joint Fit-up:** Yes No N/A**Approved Drawings:** Yes No N/A**Approved WPS:** Yes No N/A**Delayed / Cancelled:** Yes No N/A**Bridge No:** 34-0006**Component:** SAS OBG**Summary of Items Observed:**

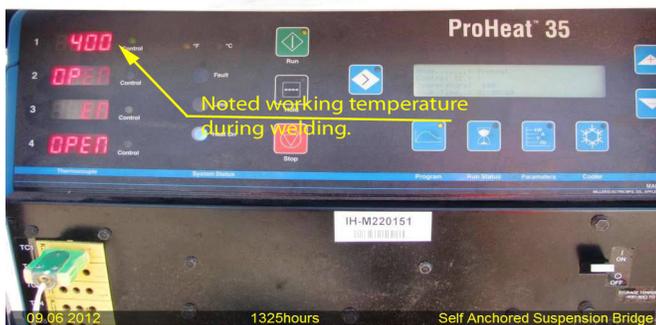
At OBG 12W-PP111.1-C1 drop-in side plate outside, ABF personnel were noted using the Miller ProHeat 35 Induction Heating System to preheat, maintain and post weld Heat treatment the weld repair during/after welding repair.

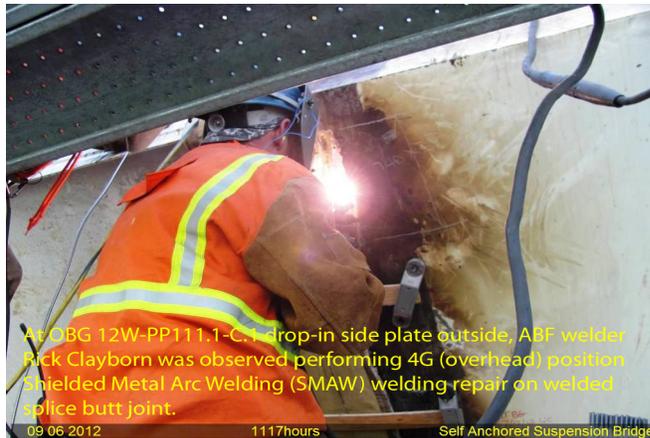
At OBG 12W-PP111.1-C1 drop-in side plate outside, ABF welder Nick Clayborn was observed performing 4G (overhead) position shielded Metal Arc Welding (SMAW) welding repair on welded splice butt joint.

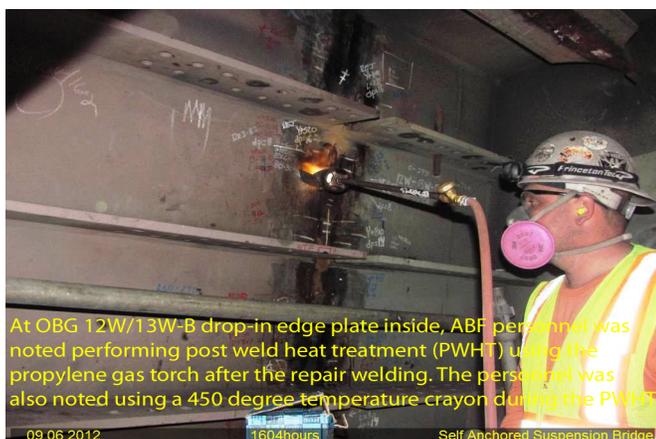
At OBG 12W/13W-B drop-in edge plate inside, ABF personnel was noted performing post weld heat treatment (PWHT) using the propylene gas torch after the repair welding. The personnel was also noted using a 450 degree temperature crayon during the PWHT.

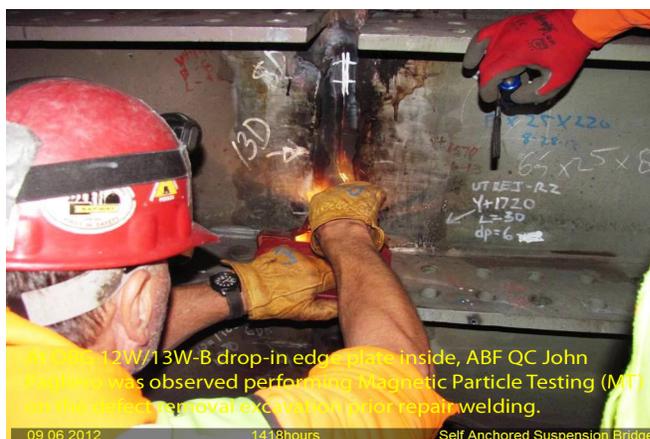
At OBG 12W/13W-B drop-in edge plate inside, ABF QC John Pagliera was observed performing Magnetic Particle Testing (MT) on the defect removal excavation prior repair welding.
