DEPARTMENT OF TRANSPORTATION

Contract #: 04-0120F4Cty: SF/ALA Rte: 80 PM: 13.2/13.9File #: 1.28**WELDING INSPECTION REPORT****Resident Engineer:** Casey, William**Address:** 333 Burma Road**City:** Oakland, CA 94607**Report No:** WIR-028329**Date Inspected:** 05-Sep-2012**Project Name:** SAS Superstructure**OSM Arrival Time:** 700**Prime Contractor:** American Bridge/Fluor Enterprises, a JV**OSM Departure Time:** 1930**Contractor:** American Bridge/Fluor Enterprises, a JV**Location:** jobsite

Bridge No: 34-0006**Summary of Items Observed:**

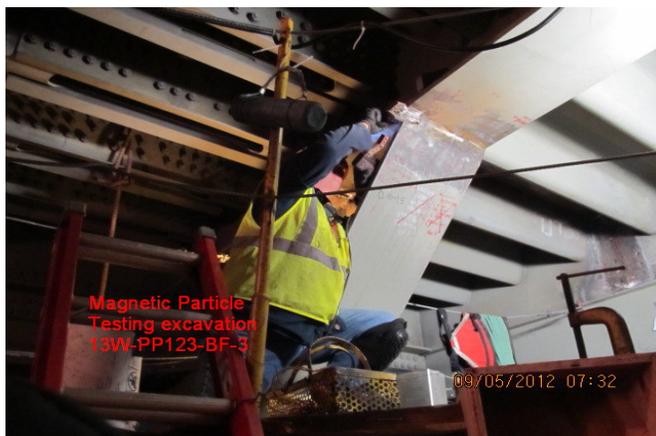
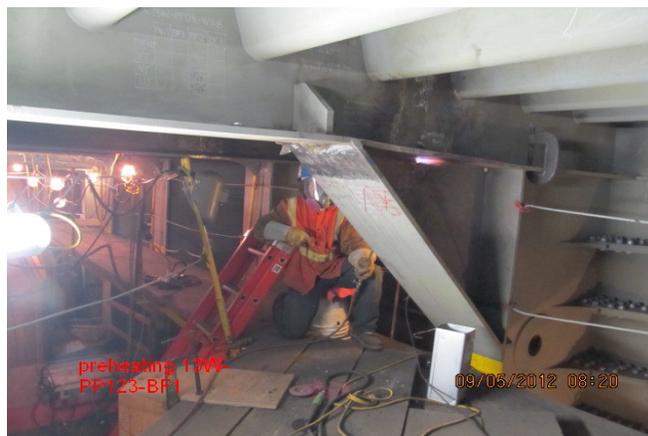
1. Weld Repairs 13W-PP123-BF-1; Y Location 240mm
2. Weld Repairs 13W-PP123-BF-3; Y Location 380mm
3. Weld Repairs 13W-PP123.5-BF-1; Y Location 230mm
