DEPARTMENT OF TRANSPORTATION

Contract #: 04-0120F4Cty: SF/ALA Rte: 80 PM: 13.2/13.9File #: 1.28**WELDING INSPECTION REPORT****Resident Engineer:** Casey, William**Address:** 333 Burma Road**City:** Oakland, CA 94607**Report No:** WIR-028330**Date Inspected:** 04-Sep-2012**Project Name:** SAS Superstructure**OSM Arrival Time:** 700**Prime Contractor:** American Bridge/Fluor Enterprises, a JV**OSM Departure Time:** 1930**Contractor:** American Bridge/Fluor Enterprises, a JV**Location:** Job site**CWI Name:** Salvador Merino**CWI Present:** Yes No**Inspected CWI report:** Yes No N/A**Rod Oven in Use:** Yes No N/A**Electrode to specification:** Yes No N/A**Weld Procedures Followed:** Yes No N/A**Qualified Welders:** Yes No N/A**Verified Joint Fit-up:** Yes No N/A**Approved Drawings:** Yes No N/A**Approved WPS:** Yes No N/A**Delayed / Cancelled:** Yes No N/A**Bridge No:** 34-0006**Component:** OBG**Summary of Items Observed:**

Ultrasonic Testing OBG

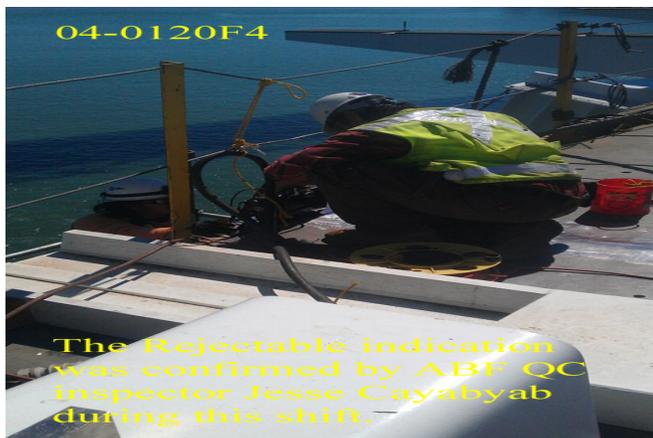
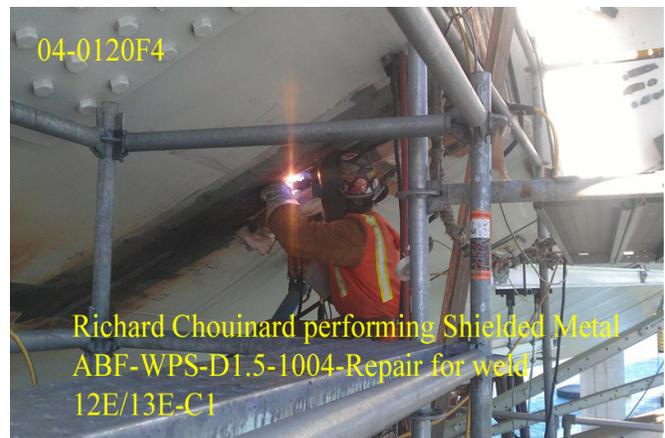
The QAI observed ABF/JV qualified welder Richard Chouinard performing Carbon Arc Gouging (CAG) for the repair of the corner assembly drop-in side plate designated as 12E/13E-C1. The ABF/JV QC inspector Salvador Merino was observed performing magnetic particle testing (MT) in way of the repair excavations at the following locations,

Weld 12E/13E-C1

Y=700 Depth 11, Width 35mm, Length 410mm

The ABF welder Richard Chouinard was observed later in the shift performing Shielded Metal Arc Welding (SMAW) in the 4G position utilizing the Caltrans approved Welding Procedure Specifications ABF-WPS-D1.5-1004-Repair at the locations previously noted. The weld and surrounding area was brought to a temperature of 325°F by the use of inductions heaters and maintained throughout the welding process. The repairs were performed in accordance with approval for repair document RWR201208-053 due to the length of the repair at this location.
