DEPARTMENT OF TRANSPORTATION

Quality Assurance and Source Inspection

Contract #: 04-0120F4Cty: SF/ALA Rte: 80 PM: 13.2/13.9File #: 1.28**WELDING INSPECTION REPORT****Resident Engineer:** Casey, William**Address:** 333 Burma Road**City:** Oakland, CA 94607**Report No:** WIR-028336**Date Inspected:** 07-Sep-2012**Project Name:** SAS Superstructure**OSM Arrival Time:** 700**Prime Contractor:** American Bridge/Fluor Enterprises, a JV**OSM Departure Time:** 1930**Contractor:** American Bridge/Fluor Enterprises, a JV**Location:** Job Site**CWI Name:** As noted below**CWI Present:** Yes No**Inspected CWI report:** Yes No N/A**Rod Oven in Use:** Yes No N/A**Electrode to specification:** Yes No N/A**Weld Procedures Followed:** Yes No N/A**Qualified Welders:** Yes No N/A**Verified Joint Fit-up:** Yes No N/A**Approved Drawings:** Yes No N/A**Approved WPS:** Yes No N/A**Delayed / Cancelled:** Yes No N/A**Bridge No:** 34-0006**Component:** SAS OBG**Summary of Items Observed:**

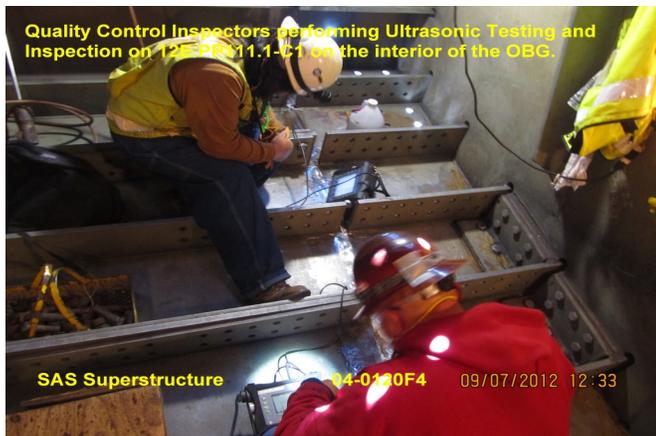
Discussed testing requirements for completed welds with Quality Control Inspector Salvador Merino.
