DEPARTMENT OF TRANSPORTATION

Contract #: 04-0120F4Cty: SF/ALA Rte: 80 PM: 13.2/13.9File #: 1.28**WELDING INSPECTION REPORT****Resident Engineer:** Casey, William**Address:** 333 Burma Road**City:** Oakland, CA 94607**Report No:** WIR-028341**Date Inspected:** 07-Sep-2012**Project Name:** SAS Superstructure**OSM Arrival Time:** 700**Prime Contractor:** American Bridge/Fluor Enterprises, a JV**OSM Departure Time:** 2100**Contractor:** American Bridge/Fluor Enterprises, a JV**Location:** jobsite**CWI Name:** Scott Kortum**CWI Present:** Yes No**Inspected CWI report:** Yes No N/A**Rod Oven in Use:** Yes No N/A**Electrode to specification:** Yes No N/A**Weld Procedures Followed:** Yes No N/A**Qualified Welders:** Yes No N/A**Verified Joint Fit-up:** Yes No N/A**Approved Drawings:** Yes No N/A**Approved WPS:** Yes No N/A**Delayed / Cancelled:** Yes No N/A**Bridge No:** 34-0006**Component:** OBG**Summary of Items Observed:**

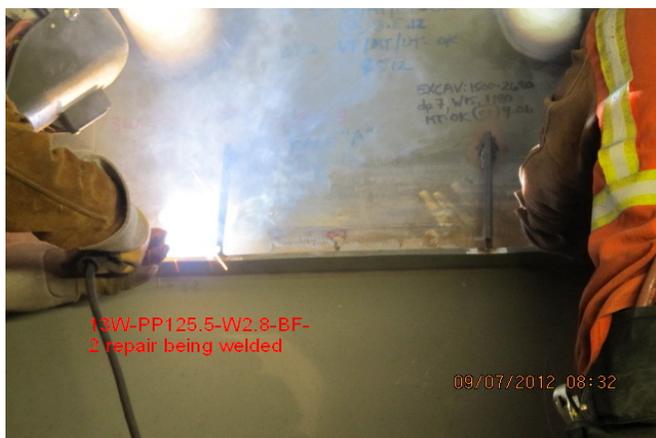
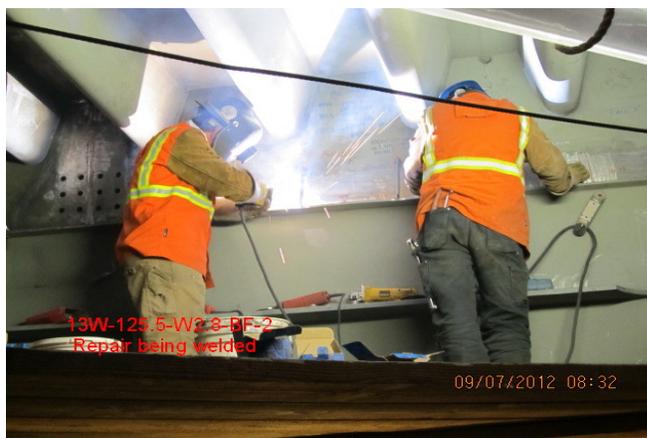
3. Critical Weld Repair 13W-PP125.5-W2.8-BF-2; Y Location: 270mm (Face B)

This QA inspector observed Critical Weld Repair being performed without Engineer Approval by ABF welding personnel Jose Torres on Floor Beam Web to Flange Weld 12W-PP125.5-W2.8-BF-2, at the following location:

Y= 300mm, D=10mm, W=15mm, L=110mm

This QA Inspector observed Mr. Torres using the Carbon Arc Gouging process to remove defects at the above-mentioned locations on the Splice, without the benefit of preheat. The locations and depth of the defects had been marked on the steel by the Ultrasonic Technician at the conclusion of his testing. At the end of gouging operations Mr. Torres ground the excavations to a bright clean metal condition in preparation of Visual and Magnetic Particle Testing.

The welder spent a part of the shift (till approx. 1630) depositing the root passes and fill passes with approximately 100% being completed prior to 1630. QC inspector Kortum was noted to be present in order to monitor the progress and ensure the welding was within the assumed Welding Procedure Specification (WPS) noted as ABF-WPS-D15-1001 Rev 0 and supporting Procedure Qualification Records (PQR). Prior to and during the welding at this location the QC inspector observed the preheat temperature using a Raytek non-contact Thermometer, was sufficient and compliant to the above-mentioned WPS. The parameters, using a Fluke brand Tong style meter, was QC recorded, QA verified to be 155 amps.

At approximately 1630 QC Technician Kortum informed this QAI that the Contractor/QC had made a mistake and they were now in full agreement that the weld joint was SPCM and the length of the excavations made it a critical repair. He informed this QAI that the contractor would be submitting a repair procedure after the fact to the Engineer. No RWR has been received by this QAI at the time of this report. The welder was then instructed to follow the requirements of WPS-ABF-WPS-1004R (REV0)
