**DEPARTMENT OF TRANSPORTATION**

Contract #: 04-0120F4Cty: SF/ALA Rte: 80 PM: 13.2/13.9File #: 1.28**WELDING INSPECTION REPORT****Resident Engineer:** Casey, William**Address:** 333 Burma Road**City:** Oakland, CA 94607**Report No:** WIR-028344**Date Inspected:** 05-Sep-2012**Project Name:** SAS Superstructure**OSM Arrival Time:** 700**Prime Contractor:** American Bridge/Fluor Enterprises, a JV**OSM Departure Time:** 1930**Contractor:** American Bridge/Fluor Enterprises, a JV**Location:** Job Site**CWI Name:** Pat Swain**CWI Present:** Yes No**Inspected CWI report:** Yes No N/A**Rod Oven in Use:** Yes No N/A**Electrode to specification:** Yes No N/A**Weld Procedures Followed:** Yes No N/A**Qualified Welders:** Yes No N/A**Verified Joint Fit-up:** Yes No N/A**Approved Drawings:** Yes No N/A**Approved WPS:** Yes No N/A**Delayed / Cancelled:** Yes No N/A**Bridge No:** 34-0006**Component:** SAS OBG**Summary of Items Observed:**

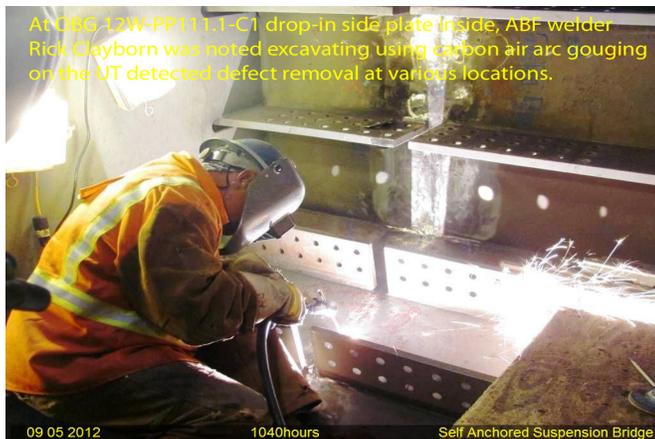
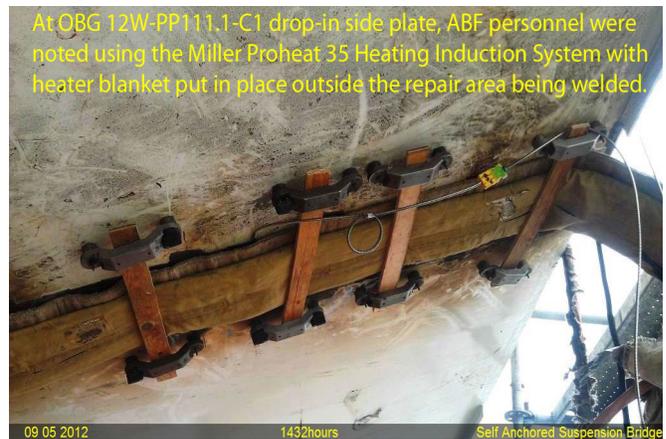
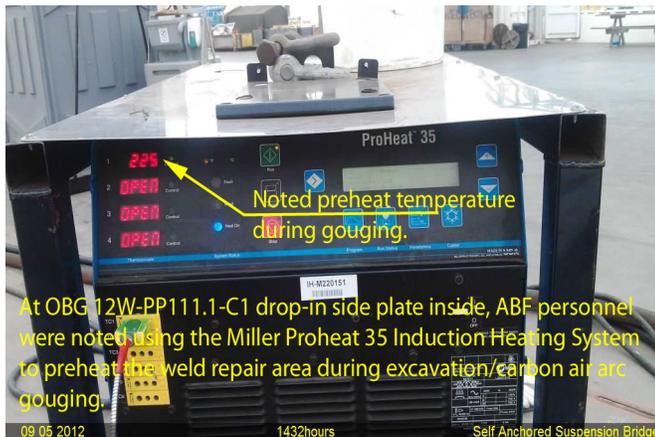
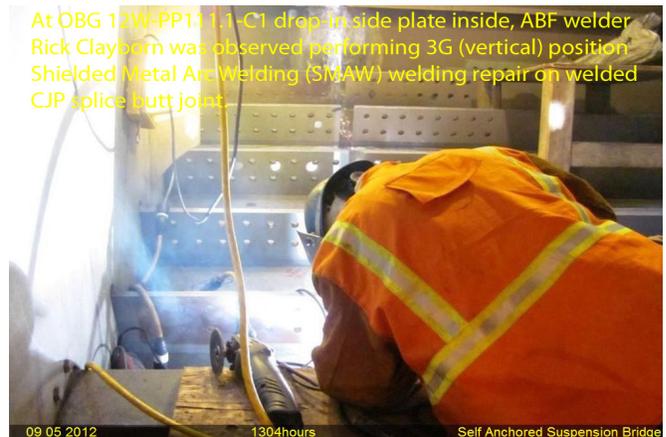
At OBG 12W-PP111.1-C1 drop-in side plate inside, QA randomly observed ABF/JV qualified welder Rick Clayborn continuing to perform CJP groove welding repair on a Seismic Performance Critical Member (SPCM) due to Ultrasonic Testing (UT) detected defects on welded splice butt joint. The welder was noted setting up the Miller Proheat 35 Induction Heating System with the heater blanket put in place from the outside to preheat the repair areas to 225°F prior and during excavation using carbon air arc gouging. The welder was given approval to excavate 17 repair at various locations per Caltrans approved Request for Weld Repair (RWR) #201209-001 to #201209-017. The welder ground smooth the groove of the excavation and after its completion, ABF QC Pat Swain performed Magnetic Particle Testing (MT) on the removal of the defects with no relevant defect noted during the test.

Y-location	Length	Width	Depth	Remarks
1. 1180mm	50mm	22mm	11mm	R2 - completed.
2. 1685mm	60mm	20mm	11mm	R2 - completed.
3. 1820mm	80mm	20mm	12mm	R2 - completed.
4. 2190mm	100mm	23mm	12mm	R2 - completed.
5. 540mm	55mm	25mm	11mm	R2 - completed.
6. 415mm	50mm	22mm	12mm	R2 - completed.
7. 485mm	50mm	22mm	12mm	R2 - completed.
8. 630mm	55mm	20mm	12mm	R2 - completed.
9. 1010mm	70mm	20mm	12mm	R2 - completed.

While waiting for the PWHT on welded repairs mentioned above, the same welder started excavating/carbon arc gouging on the repair area/whole length of the longitudinal stiffener 12W-PP111.1-W2.1 LS3 in preparation for the repair welding. The excavation was completed and the MT was performed by ABF QC Pat Swain with no relevant indication noted. According to ABF QC Pat Swain, ABF is now waiting for the approval of the RWR for repair #3 of this stiffener prior to commence welding.
