**DEPARTMENT OF TRANSPORTATION**

Contract #: 04-0120F4Cty: SF/ALA Rte: 80 PM: 13.2/13.9File #: 1.28**WELDING INSPECTION REPORT**

**Report No:** WIR-028352  
**Date Inspected:** 09-Sep-2012

**Project Name:** SAS Superstructure  
**Prime Contractor:** American Bridge/Fluor Enterprises, a JV  
**Contractor:** American Bridge/Fluor Enterprises, a JV

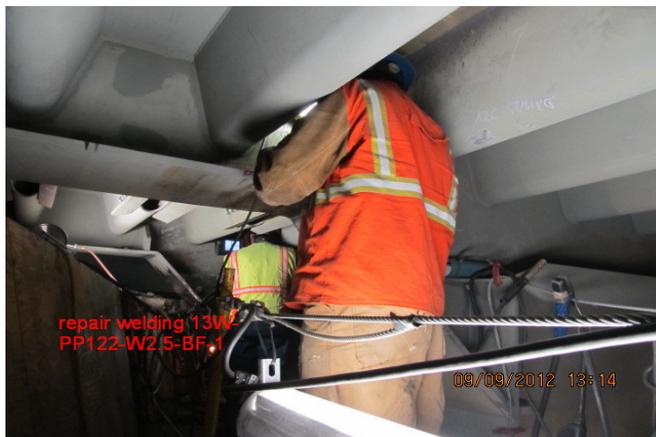
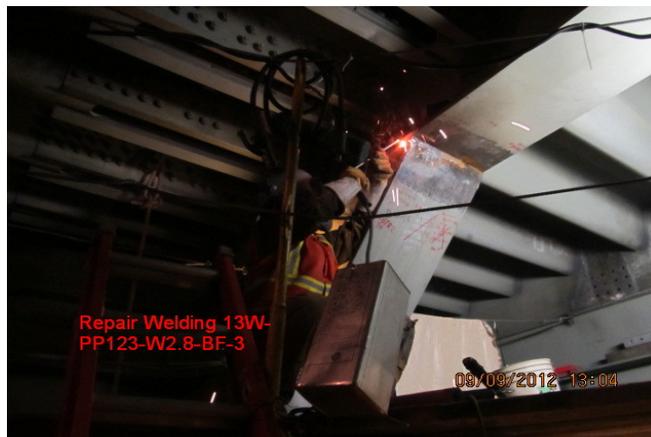
This QAI randomly observed the welder Lin E Yun grinding to a bright clean metal condition an excavation at the following location on Floor Beam Bottom Flange Splice 13W-PP122-W2.5-BF-1:

Y=50mm, D=14mm, L=140mm, W=40mm

Prior to welding Quality Control Technician Scott Kortum performed Visual and Magnetic Particle Testing on the above excavations. This Quality Assurance Inspector verified the results of the test by doing duplicate testing to the excavations. No indications were noted.

The welder spent part of the shift depositing the root passes and fill passes with approximately 100% being completed at the end of the shift. QC inspector Kortum was noted to be present in order to monitor the progress and ensure the welding was within the established Welding Procedure Specification (WPS) noted as ABF-WPS-D15-1001 Rev 0 and supporting Procedure Qualification Records (PQR). Prior to and during the welding at this location the QC inspector observed the preheat temperature using a Raytek non-contact Thermometer, was sufficient and compliant to the above-mentioned WPS. Using a Tempil Stick, (temperature

indicating crayon) the preheat was then verified by this QA inspector to be greater than 150F. The parameters, using a Fluke brand Tong style meter, were verified to be 135 amps.
