DEPARTMENT OF TRANSPORTATION

Contract #: 04-0120F4Cty: SF/ALA Rte: 80 PM: 13.2/13.9File #: 1.28**WELDING INSPECTION REPORT****Resident Engineer:** Casey, William**Address:** 333 Burma Road**City:** Oakland, CA 94607**Report No:** WIR-028382**Date Inspected:** 12-Sep-2012**Project Name:** SAS Superstructure**OSM Arrival Time:** 700**Prime Contractor:** American Bridge/Fluor Enterprises, a JV**OSM Departure Time:** 1900**Contractor:** American Bridge/Fluor Enterprises, a JV**Location:** jobsite**CWI Name:** Scott Kortum**CWI Present:** Yes No**Inspected CWI report:** Yes No N/A**Rod Oven in Use:** Yes No N/A**Electrode to specification:** Yes No N/A**Weld Procedures Followed:** Yes No N/A**Qualified Welders:** Yes No N/A**Verified Joint Fit-up:** Yes No N/A**Approved Drawings:** Yes No N/A**Approved WPS:** Yes No N/A**Delayed / Cancelled:** Yes No N/A**Bridge No:** 34-0006**Component:** OBG**Summary of Items Observed:**

WELDING INSPECTION REPORT

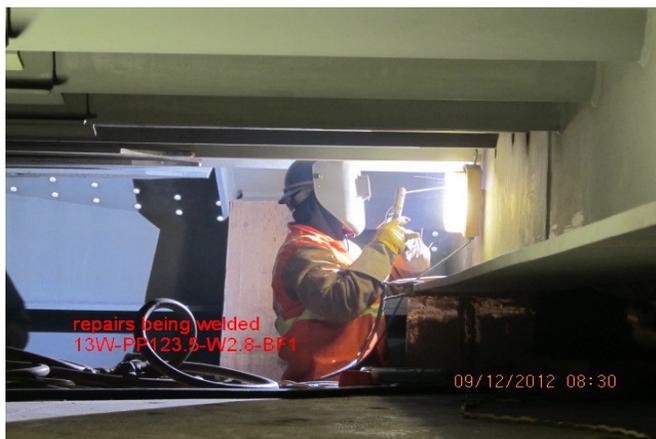
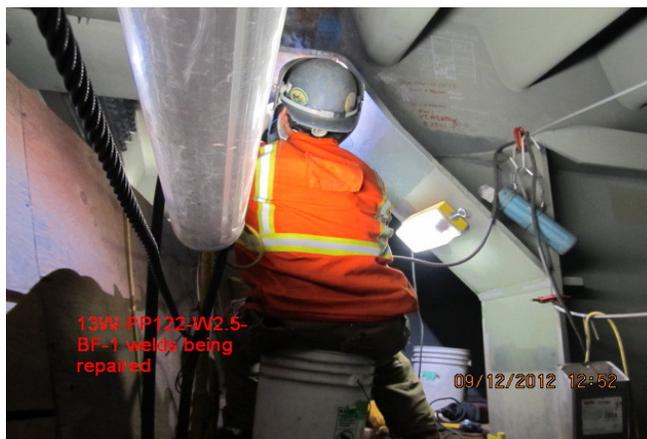
This QA inspector observed weld repair being performed by ABF welding personnel Lin E Yun on Floor Beam Web Splice 13W-PP124.5-W2.2-BW-1, at the following location(s):

This QA Inspector observed Mr. Yun preheating to a QC recorded, QA verified temperature of 250F prior to using the Carbon Arc Gouging process to remove defects at the above-mentioned locations on the Splice. The locations and depth of the defects had been marked on the steel by the Ultrasonic Technician at the conclusion of his testing. At the end of gouging operations Mr. Yun ground the excavations to a bright clean metal condition in preparation of Visual, Magnetic Particle Testing, and welding.

The welder spent a fraction of the shift depositing the root passes and fill passes with approximately 100% being completed at the end of the shift. QC inspector Scott Kortum was noted to be present in order to monitor the progress and ensure the welding was within the established Welding Procedure Specification (WPS) noted as ABF-WPS-D15-1004R (Rev 0) and supporting Procedure Qualification Records (PQR). Prior to initiating the welding at this location the QC inspector observed the preheat temperature and post heat temperature using a Raytek non-contact Thermometer, was sufficient and compliant to the above-mentioned WPS. Using a Tempil Stick, (temperature indicating crayon) the preheat, and post heat temperature was then verified by this QA inspector to be greater than 350F and 450F respectively. Using a Fluke brand Tong style meter, the parameters were verified to be 127 amps.
