DEPARTMENT OF TRANSPORTATION

Quality Assurance and Source Inspection

Contract #: 04-0120F4Cty: SF/ALA Rte: 80 PM: 13.2/13.9File #: 1.28**WELDING INSPECTION REPORT****Resident Engineer:** Casey, William**Address:** 333 Burma Road**City:** Oakland, CA 94607**Report No:** WIR-028396**Date Inspected:** 13-Sep-2012**Project Name:** SAS Superstructure**OSM Arrival Time:** 700**Prime Contractor:** American Bridge/Fluor Enterprises, a JV**OSM Departure Time:** 1930**Contractor:** American Bridge/Fluor Enterprises, a JV**Location:** S.A.S. Job site**CWI Name:** Pat Swain**CWI Present:** Yes No**Inspected CWI report:** Yes No N/A**Rod Oven in Use:** Yes No N/A**Electrode to specification:** Yes No N/A**Weld Procedures Followed:** Yes No N/A**Qualified Welders:** Yes No N/A**Verified Joint Fit-up:** Yes No N/A**Approved Drawings:** Yes No N/A**Approved WPS:** Yes No N/A**Delayed / Cancelled:** Yes No N/A**Bridge No:** 34-0006**Component:** S.A.S. Structure**Summary of Items Observed:**

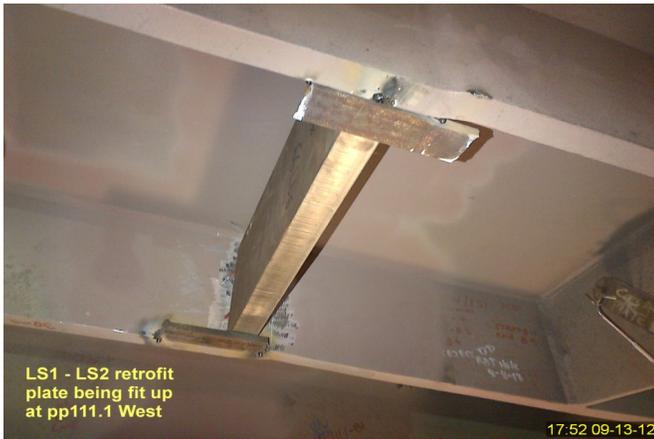
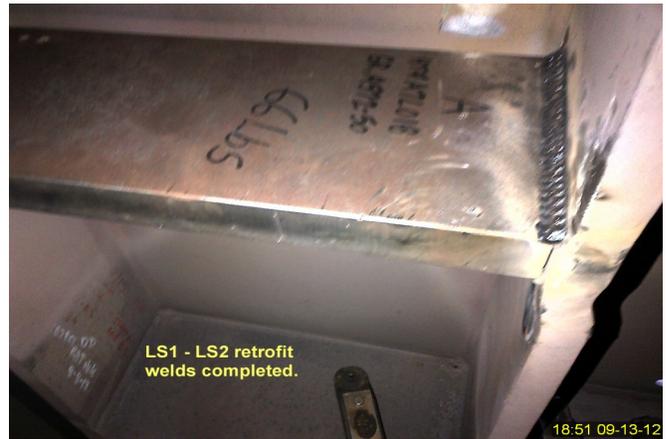
The QAI was tasked with monitoring the welding and repairs being performed by ABF welder Rick Clayborn, ID 2773. The QAI noted that retrofit of longitudinal stiffeners (LS) is being performed in OBG 12W at panel point (pp) 111.1, adjacent to the corner assembly splice welds. The QAI observed fitting and welding of the retrofit plate between LS1 and LS2. The QAI noted that the welding is being monitored by the Quality Control Inspector (QCI) Pat Swain. The QAI was informed that the vertical fillet welds (3F) are required to be 12mm size. The QAI noted that welding procedure specification (WPS) ABF-WPS-D15-F1200A is being utilized with an elevated preheat temperature due to the LS being grade 485W. The QAI noted that during the fitting and welding, the

preheat and interpass temperatures were maintained and the welding parameters were within the ranges listed on the WPS. Upon completion of 2 of the 4 welds, the QAI was informed that this work will be continued during the next shift. The QAI noted that the completed welds appeared to be visually conforming to the contract requirements but the final inspection will not be performed until the required cooling time is achieved. Reference the attached photos.
