DEPARTMENT OF TRANSPORTATION

Contract #: 04-0120F4Cty: SF/ALA Rte: 80 PM: 13.2/13.9File #: 1.28**WELDING INSPECTION REPORT****Resident Engineer:** Casey, William**Address:** 333 Burma Road**City:** Oakland, CA 94607**Report No:** WIR-028398**Date Inspected:** 15-Sep-2012**Project Name:** SAS Superstructure**OSM Arrival Time:** 700**Prime Contractor:** American Bridge/Fluor Enterprises, a JV**OSM Departure Time:** 1530**Contractor:** American Bridge/Fluor Enterprises, a JV**Location:** S.A.S. Job site**CWI Name:** Pat Swain, Barry Drake**CWI Present:** Yes No**Inspected CWI report:** Yes No N/A**Rod Oven in Use:** Yes No N/A**Electrode to specification:** Yes No N/A**Weld Procedures Followed:** Yes No N/A**Qualified Welders:** Yes No N/A**Verified Joint Fit-up:** Yes No N/A**Approved Drawings:** Yes No N/A**Approved WPS:** Yes No N/A**Delayed / Cancelled:** Yes No N/A**Bridge No:** 34-0006**Component:** S.A.S. Structure**Summary of Items Observed:**

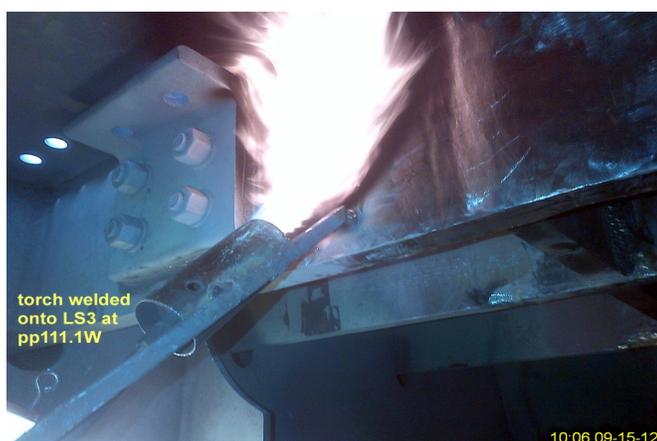
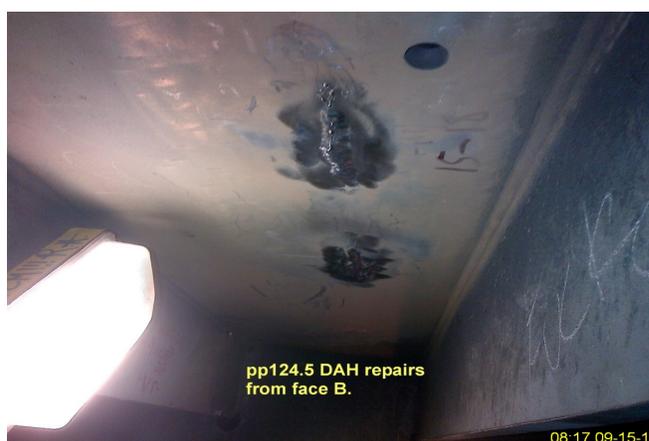
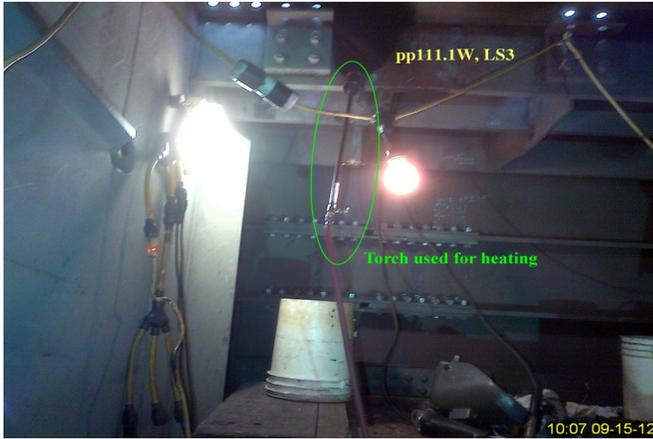
The QAI noted that work on longitudinal stiffeners (LS) is continuing in OBG 12W at panel point (pp) 111.1, adjacent to the corner assembly splice welds. The QAI observed welding of the retrofit plate between LS2 and LS3. The QAI noted that the welding is being monitored by the (QCI) Barry Drake. The QAI noted that vertical fillet welds (3F) are being made at this location. The QAI noted that ABF-WPS-D15-F1200A is being utilized with an elevated preheat temperature due to the LS being grade 485W. The QAI left the immediate work area and upon return, at approximately 1005 hours, the QAI observed a propylene torch burning unattended, inside the OBG structure at pp111.1. The QAI noted that the contractor's break time is scheduled from 1000 to 1015 hours and determined that the welder and other personnel are taking break and not in the OBG structure. The QAI extinguished the torch by turning off the fuel source and noted that the torch has been welded onto the LS3 to keep

it in position to maintain preheat on the incomplete retrofit fillet weld. The QAI immediately went to notify ABF and Caltrans personnel of the gross safety concern. The QAI notified ABF safety representative Barry and via Caltrans Engineer Doug Wright, Caltrans Safety rep Grady Hart was informed. The QAI also showed the area burned to Caltrans Engineer Sebastian Mofor. While showing Mr. Mofor, the QAI noted that the welded torch has been removed and part of the LS3 has been ground clean. The QAI informed the QCI of the observation and asked the QCI if he was aware of this. The QCI responded that he was at break and had not seen the welded torch or knew that it was burning unattended inside the OBG structure. The QAI did not raise this question with the welder, as it has already been reported to ABF safety. Upon completion of the welding, the QAI noted that inspection will not be completed until the required cooling time is achieved. The QAI issued a non-conforming incident report regarding the torch being welded onto LS3 and potential base metal damage. Reference the TL-15IR for additional information. See the attached photos.

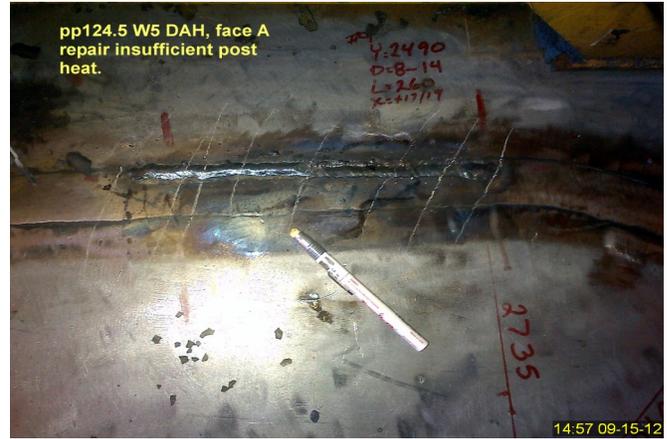
The QAI was informed that repairs at DAH, pp124.5, line W5, top side (face A) will be performed. The QAI noted that this weld is designated as SPCM. The QAI witnessed the excavation of the DAH weld that has been identified by QCI examination as rejectable. The location chosen for repair is Y=2490mm and after excavation the dimensions are: Y=2490; 18mm W; 11.5mm D; 300mm L. The QAI noted that the excavations were examined with MT by the QCI Pat Swain. The QAI observed that during the welding, the preheat and interpass temperatures were maintained and the welding parameters were within the ranges listed on ABF-WPS-D15-1004-Repair. The QAI noted that the welding was monitored by the QCI Pat Swain. At 1415 hours, the QAI noted that welding is still in progress and asked how long the work would continue, as there is a 1 hour post heat required. The welder replied that they would stop now and begin the post heat. The QAI monitored that the post heat was being performed to 450F and returned at 1500 hours to verify. Upon return to the weld repair, the QAI noted that there are no welders or workers in the area and the weld was not being heated. The QAI verified that the temperature of the weld repair was significantly less than the required 450F. The QAI informed the QCI William Sherwood, as he was in the vicinity. The QAI issued a non-conforming incident report regarding the lack of post heat on the weld repair. Reference the TL-15IR for additional information. See the attached photo.
