Contract #: 04-0120F4Cty: SF/ALA Rte: 80 PM: 13.2/13.9File #: 1.28**WELDING INSPECTION REPORT**

Report No: WIR-028399
Date Inspected: 17-Sep-2012

Project Name: SAS Superstructure
Prime Contractor: American Bridge/Fluor Enterprises, a JV
Contractor: American Bridge/Fluor Enterprises, a JV

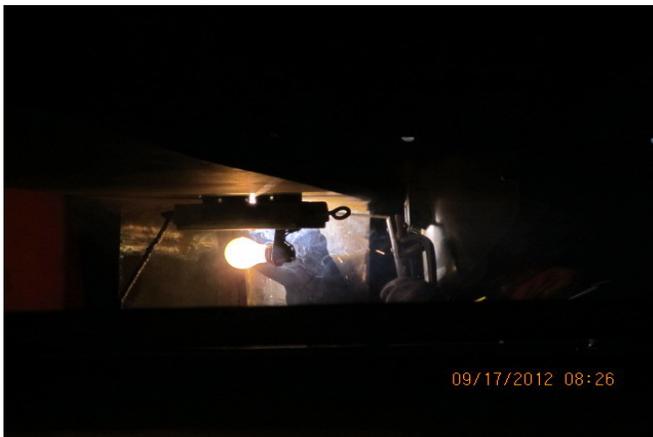
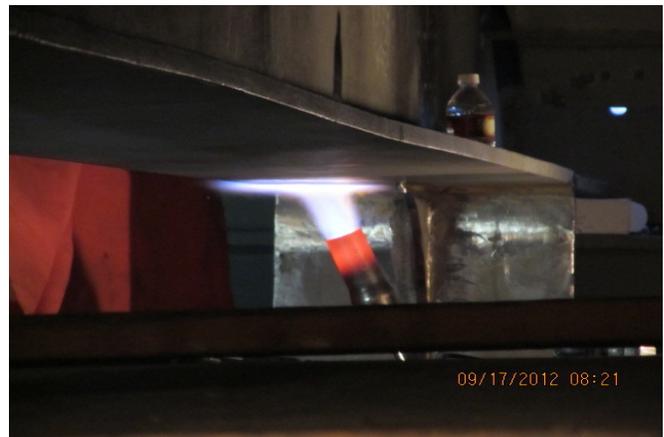
This QAI observed the fitting of gusset plate BR-1 to column and floor beam 13W-PP124.5-W2.1 by ABF Welder Richard Chouinard. Prior to fitting of the gusset plate the welder removed the prime paint in the areas weld would be deposited by grinding. At the conclusion of grinding the gusset plate was fit square to the column and bottom flange of the floor beam and tacked into place using the Shield Metal Arc welding with E7018 H4R electrode.

This QA inspector observed weld repair being performed by ABF welding personnel Jimmy Zen on Floor Beam

Splice 13W-PP125.5-W2.8-BF-2 (Face A), at the following location(s):

Y: 1730mm, L: 150mm, W: 30mm, D: 12mm

This QA Inspector observed Mr. Zen preheating to a QC recorded, QA verified temperature of 250F prior to using the Carbon Arc Gouging process to remove defects at the above-mentioned locations on the Splice. The locations and depth of the defects had been marked on the steel by the Ultrasonic Technician at the conclusion of his testing. At the end of gouging operations Mr. Zen ground the excavations to a bright clean metal condition in preparation of Visual, Magnetic Particle Testing, and welding.

Prior to welding Quality Control Technician Scott Kortum performed Visual and Magnetic Particle Testing on the above excavations. This Quality Assurance Inspector verified the results of the test by doing duplicate testing to the excavations. No indications were noted.

The welder spent a fraction of the shift depositing the root passes and fill passes with approximately 100% being completed at the end of the shift. QC inspector Scott Kortum was noted to be present in order to monitor the progress and ensure the welding was within the established Welding Procedure Specification (WPS) noted as ABF-WPS-D15-1004R (Rev 0) and supporting Procedure Qualification Records (PQR). Prior to initiating the welding at this location the QC inspector observed the preheat temperature and post heat temperature using a Raytek non-contact Thermometer, was sufficient and compliant to the above-mentioned WPS. Using a Tempil Stick, (temperature indicating crayon) the preheat, and post heat temperature was then verified by this QA inspector to be greater than 350F and 450F respectively. Using a Fluke brand Tong style meter, the parameters were verified to be 133 amps
