DEPARTMENT OF TRANSPORTATION

Contract #: 04-0120F4Cty: SF/ALA Rte: 80 PM: 13.2/13.9File #: 1.28**WELDING INSPECTION REPORT****Resident Engineer:** Casey, William**Address:** 333 Burma Road**City:** Oakland, CA 94607**Report No:** WIR-028419**Date Inspected:** 18-Sep-2012**Project Name:** SAS Superstructure**OSM Arrival Time:** 700**Prime Contractor:** American Bridge/Fluor Enterprises, a JV**OSM Departure Time:** 1930**Contractor:** American Bridge/Fluor Enterprises, a JV**Location:** Job Site

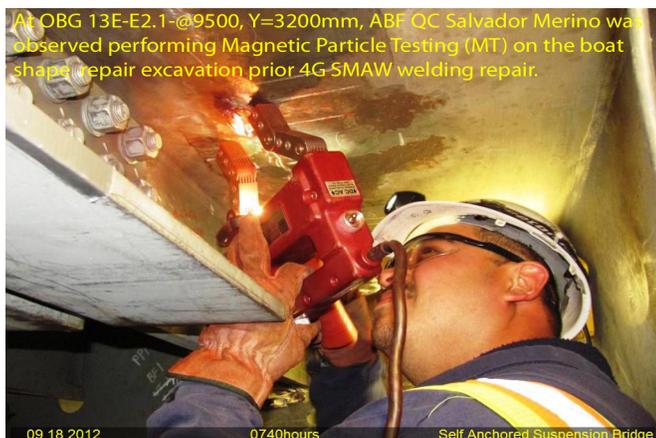
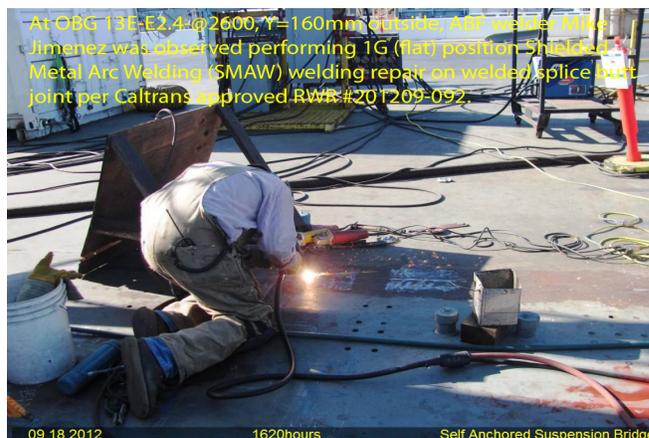
At OBG 13E-E2.1-@9500 drop-in top deck plate inside, QA randomly observed ABF/JV qualified welder Mike Jimenez continuing to perform CJP groove welding repair at location Y=3200mm. The repair was having a boat shape excavation profile of 70mm long x 25mm wide x 10mm deep. The welder was observed manually welding in the 4G (overhead) position utilizing Shielded Metal Arc Welding (SMAW) with 3.2mm diameter E7018H4R electrode implementing Caltrans approved welding procedure ABF-WPS-D15-1004-Repair. The repair has been excavated and being welded per Caltrans approved Request for Weld Repair (RWR) #201209-090. The repair excavation was preheated to more than 225 degree Fahrenheit using propylene gas torch. After the completion of excavation and removal MT verification from ABF QC Salvador Merino and this QA, the welder pumped up the preheat to more than 325°F using the same torch during welding. ABF QC Salvador Merino was noted monitoring the welder with measured working current of 130 amperes. During the shift, repair welding at location mentioned above was completed and the welder has moved to another location OBG 13E-E2.4-@2600 Y=160mm with Caltrans approval per RWR #201209-092. The boat shape repair excavation has profile of 90mm long x 35mm wide x 13mm deep and welded from the inside then moved to the top side and excavated having profile of 85mm long x 25mm wide x 8mm deep and welded. The welder followed the same steps and procedure mentioned above in completing the weld repair.

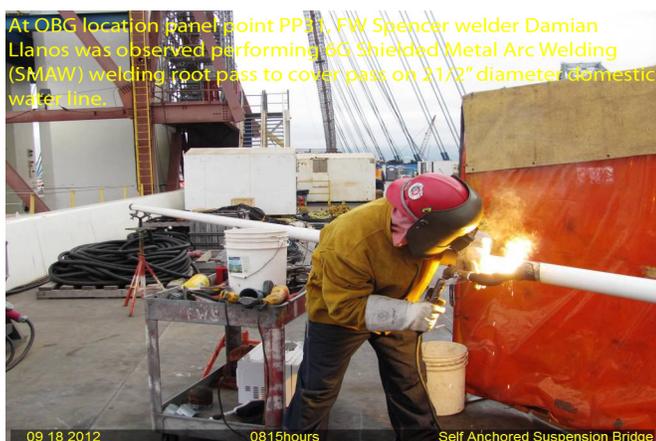
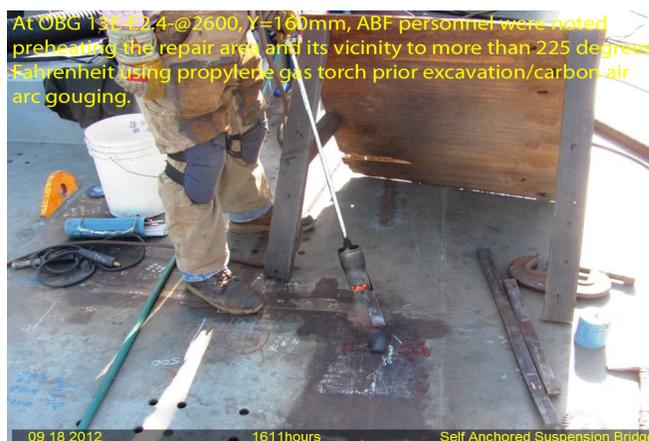
welder Damian Llanos perform Complete Joint Penetration (CJP) 6G (all position) Shielded Metal Arc Welding (SMAW) welding root pass to cover pass on the field splice butt joint of 2.5" and 4" domestic water and compressed air lines respectively. The system lines being welded are field weld joints along the grid line of E5 of the OBG. The welder was noted welding the root pass with 3/32" diameter E6010 electrode and followed by fill pass to cover pass using 3/32" diameter E7018H4R electrode implementing Caltrans approved procedure FW Spencer WPS 1-12-1. The welder was noted preheating and removing the moisture of the joint using a portable propane gas torch prior welding. During welding, ABF QC Fred Michels was noted monitoring the parameters of the welder. At the end of the shift, the welder has completed the welding of the field splice butt joints at the following;

1 Domestic Water	2 ½"	31 Northeast	15.5/2.5/31/NE
2 Compressed Air	4"	33 Northeast	15.5/4/33/NE
3 Domestic Water	2 ½"	33 Northeast	16/2.5/33/NE
4 Compressed Air	4"	33 Northeast	15.5/4/33/NE
