**DEPARTMENT OF TRANSPORTATION**

Contract #: 04-0120F4Cty: SF/ALA Rte: 80 PM: 13.2/13.9File #: 1.28**WELDING INSPECTION REPORT****Resident Engineer:** Casey, William**Address:** 333 Burma Road**City:** Oakland, CA 94607**Report No:** WIR-028421**Date Inspected:** 19-Sep-2012**Project Name:** SAS Superstructure**OSM Arrival Time:** 700**Prime Contractor:** American Bridge/Fluor Enterprises, a JV**OSM Departure Time:** 1730**Contractor:** American Bridge/Fluor Enterprises, a JV**Location:** Job Site

# WELDING INSPECTION REPORT

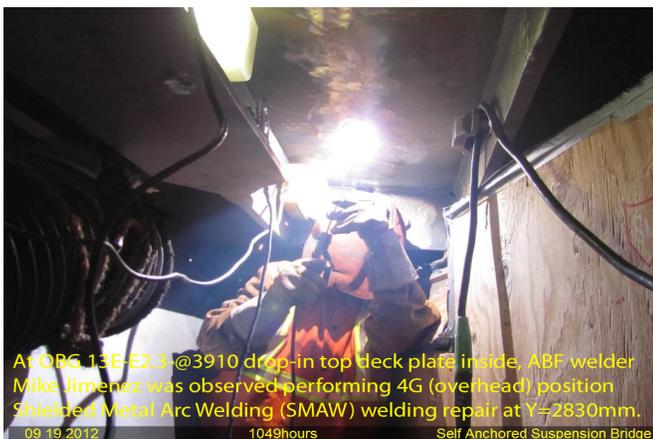
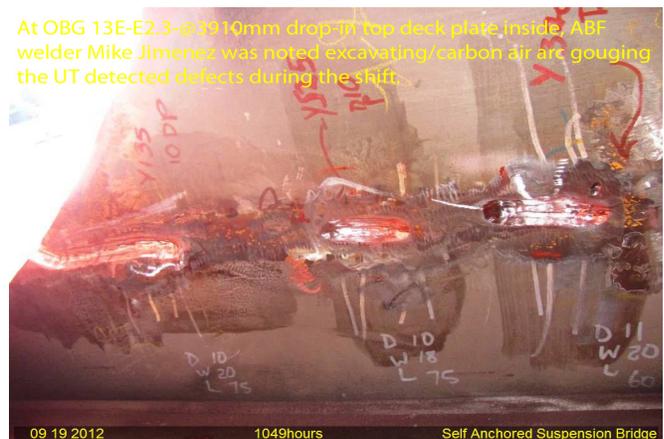
At OBG 13E-E2.3-@3910 drop-in top deck plate inside, QA randomly observed ABF/JV qualified welder Mike Jimenez continuing to perform CJP groove welding repair on a Seismic Performance Critical Member (SPCM) due to Ultrasonic Testing (UT) detected defect on welded splice butt joint. The welder preheated the repair area and its vicinity to >225°F using propylene gas torch prior excavation and then ground smooth the groove of the excavation. After its completion, ABF QC Salvador Merino performed Magnetic Particle Testing (MT) on the removal of the defects with no relevant defect noted during the test. This QA also performed same test verification and noted same result.

One dedicated ABF personnel was noted using propylene gas torch to preheat the repair area and its vicinity to 325°F and as soon as the required temperature was attained the welder started performing the welding repair. Welder Mike Jimenez was observed manually welding in 4G (overhead) position utilizing Shielded Metal Arc Welding (SMAW) with 3.2mm diameter E7018H4R electrode implementing Caltrans approved welding procedure ABF-WPS-D15-1004 Repair. Welder Mike Jimenez was noted welding five (5) second time and one (1) fourth time repairs at various Y locations listed below. During welding, ABF QC Salvador Merino was noted monitoring the welder's welding parameter with measured working current of 128 amperes on the 3.2mm diameter E7018H4R electrode. Each time the welder has completed one repair, an ABF personnel was noted performing the post weld heat treatment (PWHT) using the propylene gas torch and verifying the heat using the 450°F for one hour as

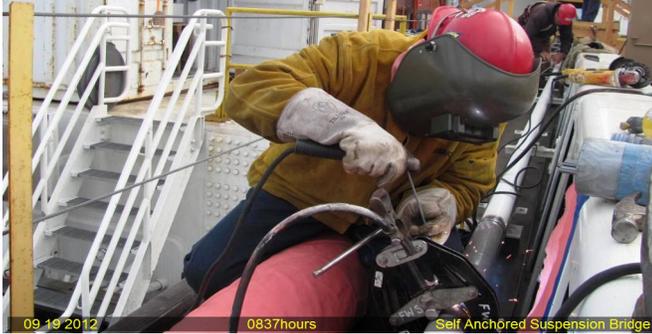
At OBG location panel point PP31 grid line E5 outside, FW Spencer welder Damian LLanos was observed performing 6G (all position) Shielded Metal Arc Welding (SMAW) welding root pass to cover pass on field-splice 2 1/2" diameter domestic water line.

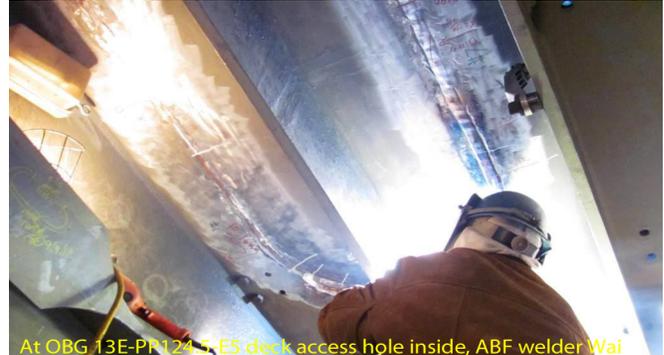
At OBG 13E-PP124.5-E5 deck access hole inside, ABF welder Wai Kit Lai was observed performing 4G (overhead) position Shielded Metal Arc Welding (SMAW) welding repair on welded access hole.
