DEPARTMENT OF TRANSPORTATION

Contract #: 04-0120F4Cty: SF/ALA Rte: 80 PM: 13.2/13.9File #: 1.28**WELDING INSPECTION REPORT****Resident Engineer:** Casey, William**Address:** 333 Burma Road**City:** Oakland, CA 94607**Report No:** WIR-028432**Date Inspected:** 13-Sep-2012**Project Name:** SAS Superstructure**OSM Arrival Time:** 700**Prime Contractor:** American Bridge/Fluor Enterprises, a JV**OSM Departure Time:** 1930**Contractor:** American Bridge/Fluor Enterprises, a JV**Location:** Job Site**CWI Name:** As noted below**CWI Present:** Yes No**Inspected CWI report:** Yes No N/A**Rod Oven in Use:** Yes No N/A**Electrode to specification:** Yes No N/A**Weld Procedures Followed:** Yes No N/A**Qualified Welders:** Yes No N/A**Verified Joint Fit-up:** Yes No N/A**Approved Drawings:** Yes No N/A**Approved WPS:** Yes No N/A**Delayed / Cancelled:** Yes No N/A**Bridge No:** 34-0006**Component:** SAS OBG**Summary of Items Observed:**

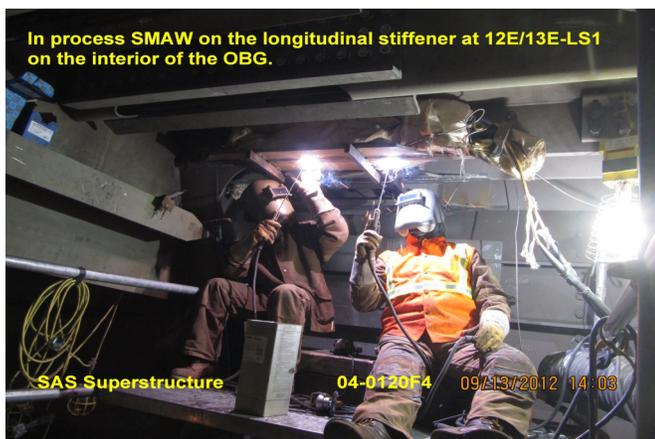
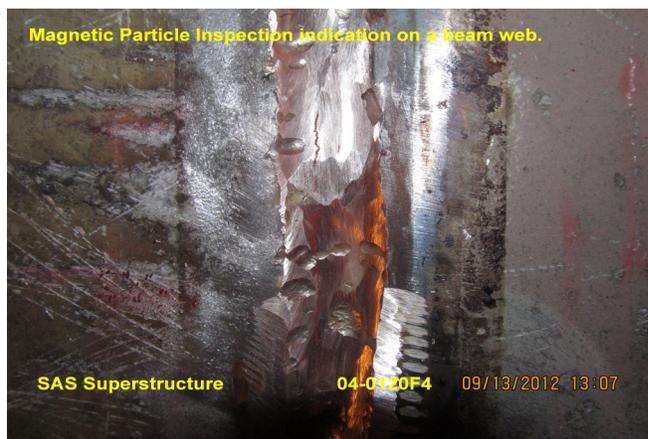
Conversation with Quality Control Inspector Steve Jensen concerning planar offset on plate stiffeners.
