**DEPARTMENT OF TRANSPORTATION**

Contract #: 04-0120F4Cty: SF/ALA Rte: 80 PM: 13.2/13.9File #: 1.28**WELDING INSPECTION REPORT****Resident Engineer:** Casey, William**Address:** 333 Burma Road**City:** Oakland, CA 94607**Report No:** WIR-028434**Date Inspected:** 14-Sep-2012**Project Name:** SAS Superstructure**OSM Arrival Time:** 700**Prime Contractor:** American Bridge/Fluor Enterprises, a JV**OSM Departure Time:** 1930**Contractor:** American Bridge/Fluor Enterprises, a JV**Location:** Job Site**CWI Name:** As noted below**CWI Present:** Yes No**Inspected CWI report:** Yes No N/A**Rod Oven in Use:** Yes No N/A**Electrode to specification:** Yes No N/A**Weld Procedures Followed:** Yes No N/A**Qualified Welders:** Yes No N/A**Verified Joint Fit-up:** Yes No N/A**Approved Drawings:** Yes No N/A**Approved WPS:** Yes No N/A**Delayed / Cancelled:** Yes No N/A**Bridge No:** 34-0006**Component:** SAS OBG**Summary of Items Observed:**

# WELDING INSPECTION REPORT

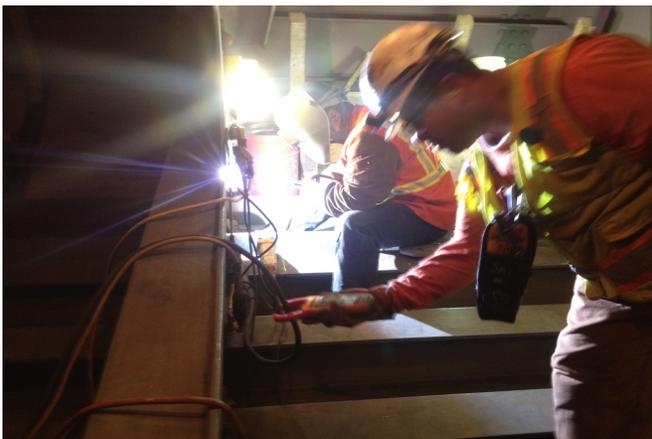
This QA Inspector made random observations of ABF/JV qualified welder Deli Zhang #4735 performing the SMAW process in the 2G horizontal position utilizing E7018-H4R electrodes on the plate stiffener located at 12E PP111.5-PS1 on the interior of the OBG. QC Inspector Salvador Merino verified the temperature and recorded the parameters as acceptable and within the requirements of ABF-WPS-D1.5-1040A-CU-Revision 2. The welder was observed welding the height of the joint followed by grinding and blending of the work utilizing a small disc grinder. On a subsequent observation, this QA Inspector noted that the welding was performed in the 2G horizontal position utilizing the E7018-H4R low hydrogen electrodes. The 3.2mm electrodes were stored in electrically heated, thermostatically controlled oven after removal from the sealed containers. The exposure limits of the electrodes appeared to comply with the minimum storage oven temperature of 120 degrees Celsius as per the contract documents. The welding parameters and surface temperatures were verified by the QC inspector's utilizing a Fluke 337 clamp meter to measure the electrical welding parameters and Tempilstik Heat Indicators for verifying the preheat and inter-pass temperatures. At the time of the observation no issues were noted by the QA. On subsequent observations throughout the shift to monitor quality, it was noted that the work was in progress and appeared to be in general conformance with the contract documents.
