**DEPARTMENT OF TRANSPORTATION**

Contract #: 04-0120F4Cty: SF/ALA Rte: 80 PM: 13.2/13.9File #: 1.28**WELDING INSPECTION REPORT****Resident Engineer:** Casey, William**Address:** 333 Burma Road**City:** Oakland, CA 94607**Report No:** WIR-028435**Date Inspected:** 15-Sep-2012**Project Name:** SAS Superstructure**OSM Arrival Time:** 700**Prime Contractor:** American Bridge/Fluor Enterprises, a JV**OSM Departure Time:** 1530**Contractor:** American Bridge/Fluor Enterprises, a JV**Location:** Job Site**CWI Name:** As noted below**CWI Present:** Yes No**Inspected CWI report:** Yes No N/A**Rod Oven in Use:** Yes No N/A**Electrode to specification:** Yes No N/A**Weld Procedures Followed:** Yes No N/A**Qualified Welders:** Yes No N/A**Verified Joint Fit-up:** Yes No N/A**Approved Drawings:** Yes No N/A**Approved WPS:** Yes No N/A**Delayed / Cancelled:** Yes No N/A**Bridge No:** 34-0006**Component:** SAS OBG**Summary of Items Observed:**

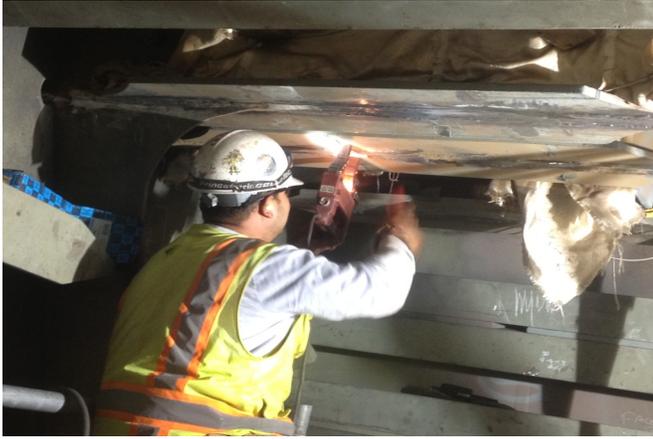
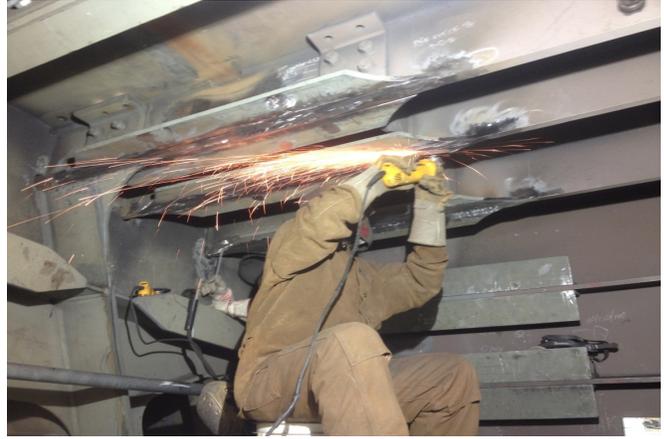
This QA Inspector randomly observed the excavation operations of Ultrasonic rejectable indications on the Complete Joint Penetration (CJP) joint at 13E-E2.1 on the interior of the OBG. This QA Inspector observed ABF/JV qualified welder Mike Jimenez #4671 performing the Carbon Arc Gouging (CAG) method to remove metal from the material. The welder was observed cleaning up the excavations utilizing a small disc grinder and a de-burring drill. Upon completion of the excavation, Quality Control (QC) Inspector Bernie Docena performed a Magnetic Particle Inspection (MT) of the site to determine soundness of the metal and observed no indications, QC then measured the dimensions of the excavations for length, width and depth. This QA Inspector recorded the dimensions of the excavations as:

Y=2575mm; 70mm in length, 30mm wide and 12mm deep.

Prior to welding, QC Inspector Bernie Docena was observed monitoring and measuring the pre-heat temperatures and parameters as they pertain to ABF-WPS-D1.5-1002-Repair-Revision 0. This QA Inspector made random observations of SMAW in the 4G overhead position and noted no issues with the work at this location and at the time of this repair, no RWR was required for this first time weld repair. This QA Inspector made subsequent observations throughout the shift to monitor quality and it was noted that the E7018-H4R electrodes were stored properly in a sealed container after being opened and they were drawing amperage of 136. The welder was observed continuing the in process repair welding and this QA Inspector noted that no issues were present at this location. QC Inspector Bernie Docena was also present to monitor the welding and the parameters in the later stages of the shift. This QA Inspector noted that the work at this location was completed on this date and appeared to be in general conformance with the contract specifications.
