Contract #: 04-0120F4Cty: SF/ALA Rte: 80 PM: 13.2/13.9File #: 1.28**WELDING INSPECTION REPORT**

Report No: WIR-028439
Date Inspected: 17-Sep-2012

Project Name: SAS Superstructure
Prime Contractor: American Bridge/Fluor Enterprises, a JV
Contractor: American Bridge/Fluor Enterprises, a JV

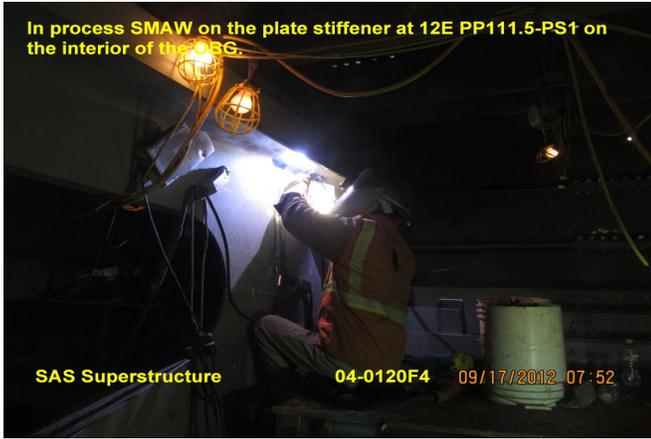
This QA Inspector randomly observed the Visual Testing (VT) indication repairs conducted by ABF/JV qualified welders Deli Zhang #4735 and Xiao Hua Luo #1291 on the overhead weld seam at 12E-E2.1 on the interior of the OBG. Welder Zhang performed SMAW to fill low spots followed by grinding and blending to provide a smooth consistent surface area on E2.1 between PP111.1 to PP111.5. Welder Luo performed SMAW to fill low spots followed by grinding and blending to provide a smooth consistent surface area on E2.1 between PP112 to PP112.5. QC Salvador Merino verified the temperature and recorded the parameters as acceptable and within the requirements of ABF-WPS-D1.5-1001-Repair. The welders were observed welding the joint followed by grinding and blending of the work utilizing a small disc grinder. On a subsequent observation, this QA Inspector noted that the welding was performed in the 4G horizontal position utilizing the E7018-H4R low hydrogen electrodes. The 3.2mm electrodes were stored in electrically heated, thermostatically controlled oven after removal from the sealed containers. The exposure limits of the electrodes appeared to comply with the minimum storage oven temperature of 120 degrees Celsius as per the contract documents. The welding parameters and surface temperatures were verified by the QC inspector's utilizing a Fluke 337 clamp meter to measure the electrical welding parameters and Tempilstik Heat Indicators for verifying the preheat and inter-pass temperatures. At the time of the observation no issues were noted by the QA. On subsequent observations throughout the shift to monitor quality, it was noted that the work was in progress and appeared to be in general conformance with the contract documents.
