Contract #: 04-0120F4Cty: SF/ALA Rte: 80 PM: 13.2/13.9File #: 1.28**WELDING INSPECTION REPORT****Resident Engineer:** Casey, William**Address:** 333 Burma Road**City:** Oakland, CA 94607**Report No:** WIR-028466**Date Inspected:** 21-Sep-2012**Project Name:** SAS Superstructure**OSM Arrival Time:** 700**Prime Contractor:** American Bridge/Fluor Enterprises, a JV**OSM Departure Time:** 1730**Contractor:** American Bridge/Fluor Enterprises, a JV**Location:** jobsite**CWI Name:** Chris Concha**CWI Present:** Yes No**Inspected CWI report:** Yes No N/A**Rod Oven in Use:** Yes No N/A**Electrode to specification:** Yes No N/A**Weld Procedures Followed:** Yes No N/A**Qualified Welders:** Yes No N/A**Verified Joint Fit-up:** Yes No N/A**Approved Drawings:** Yes No N/A**Approved WPS:** Yes No N/A**Delayed / Cancelled:** Yes No N/A**Bridge No:** 34-0006**Component:** OBG**Summary of Items Observed:**

WELDING INSPECTION REPORT

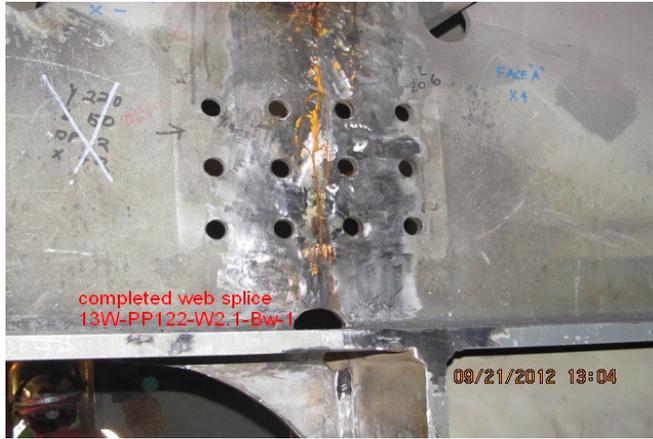
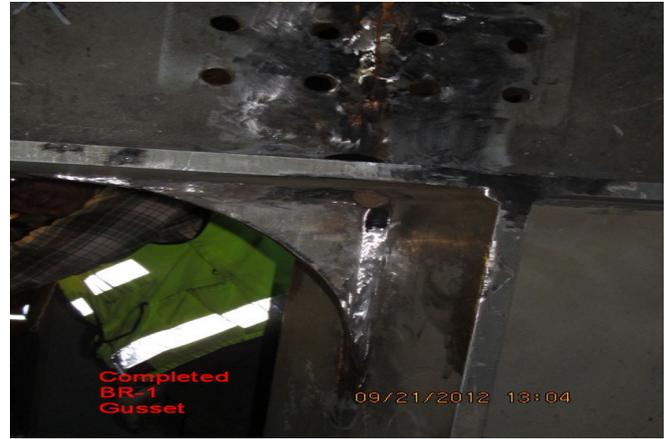
This QAI observed the fitting of gusset plate BR-1 to column and floor beam 13W-PP123-W2.1 by ABF Welder Richard Chouinard. Prior to fitting of the gusset plate the welder removed the prime paint in the areas weld would be deposited by grinding. At the conclusion of grinding the gusset plate was fit square to the column and bottom flange of the floor beam and tacked into place using the Shield Metal Arc welding with E7018 H4R electrode.

This QAI observed the fitting of gusset plate BR-1 to column and floor beam 13W-PP122.5-W2.1 by ABF Welder Richard Garcia. Prior to fitting of the gusset plate the welder removed the prime paint in the areas weld would be deposited by grinding. At the conclusion of grinding the gusset plate was fit square to the column and

This QAI from time to time observed the welder Richard Garcia grinding to a bright clean metal condition an excavation at the following location on Floor Beam Bottom Flange Splice 13W-PP124-W2.2-BF-1:

Prior to welding Quality Control Technician Chris Concha performed Visual and Magnetic Particle Testing on the above excavations. This Quality Assurance Inspector verified the results of the test by doing duplicate testing to the excavations. No indications were noted.
