**DEPARTMENT OF TRANSPORTATION**

Contract #: 04-0120F4Cty: SF/ALA Rte: 80 PM: 13.2/13.9File #: 1.28**WELDING INSPECTION REPORT****Resident Engineer:** Casey, William**Address:** 333 Burma Road**City:** Oakland, CA 94607**Report No:** WIR-028488**Date Inspected:** 24-Sep-2012**Project Name:** SAS Superstructure**OSM Arrival Time:** 700**Prime Contractor:** American Bridge/Fluor Enterprises, a JV**OSM Departure Time:** 1930**Contractor:** American Bridge/Fluor Enterprises, a JV**Location:** Job Site

Caltrans Office of Structural Material (OSM) Quality Assurance Inspector (QAI) Joselito Lizardo was present at the Self Anchored Suspension (SAS) job site as requested to perform observations on the welding of components for the San Francisco Oakland Bay Bridge (SFOBB) Project.

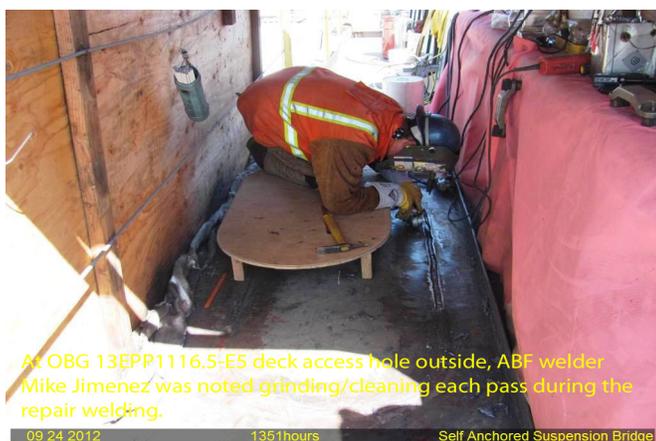
At OBG 12E-PP116.5-E5 deck access hole outside, QA randomly observed ABF/JV qualified welder Mike Jimenez continuing to perform CJP groove welding repair on a Seismic Performance Critical Member (SPCM) due to Ultrasonic Testing (UT) detected defect on welded splice butt joint. The welder preheated the repair area and its vicinity to >225°F using propylene gas torch prior excavation and then ground smooth the groove of the excavation. After its completion, ABF QC William Sherwood performed Magnetic Particle Testing (MT) on the removal of the defects with no relevant defect noted during the test. This QA also performed same test verification and noted same result.

The welder was noted using propylene gas torch to preheat the repair area and its vicinity to 325°F and as soon as the required temperature was attained the welder started performing the welding repair. Welder Mike Jimenez was observed manually welding in 1G (flat) position utilizing Shielded Metal Arc Welding (SMAW) with 3.2mm and 4.0mm diameter E7018H4R electrode implementing Caltrans approved welding procedure ABF-WPS-D15-1004 Repair. Welder Mike Jimenez was noted welding at location Y=600mm to Y=1500mm. During welding, ABF QC William Sherwood was noted monitoring the welder's welding parameter with measured working current of 130 amperes on the 3.2mm and 190 amperes on 4.0mm diameter E7018H4R electrodes. During the shift, repair welding at the location mentioned above was completed and the welder has moved to location Y=1800mm and performed the same welding repair. The welder continued welding the repair until the end of the shift wherein he

was not able to complete. The welder performed the post weld heat treatment of 450°F on the completed repair and the incomplete one using the Miller Proheat 35 Induction Heating System and held it for one hour as required.

Y-location	Length	Width	Depth	RWR#	Remarks
1.	600mm	900mm	25mm	12mm	201208-115 R2- completed.
2.	1800mm	700mm	35mm	11mm	201208-115 R2- in progress.
