Contract #: 04-0120F4Cty: SF/ALA Rte: 80 PM: 13.2/13.9File #: 1.28**WELDING INSPECTION REPORT****Resident Engineer:** Casey, William**Address:** 333 Burma Road**City:** Oakland, CA 94607**Report No:** WIR-028492**Date Inspected:** 24-Sep-2012**Project Name:** SAS Superstructure**OSM Arrival Time:** 730**Prime Contractor:** American Bridge/Fluor Enterprises, a JV**OSM Departure Time:** 2000**Contractor:** American Bridge/Fluor Enterprises, a JV**Location:** S.A.S. Job site

Bridge No: 34-0006**Component:** S.A.S. Structure**Summary of Items Observed:**

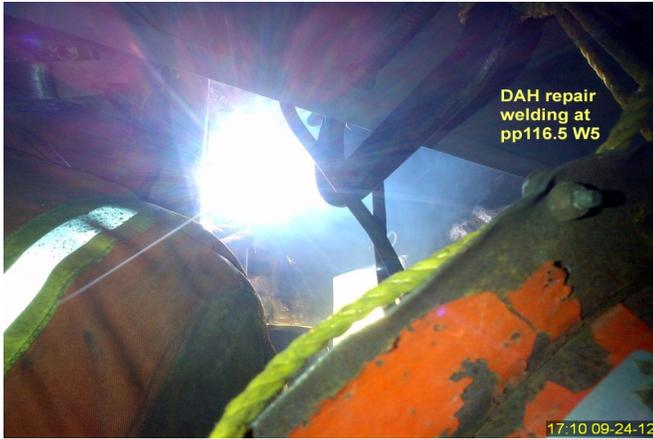
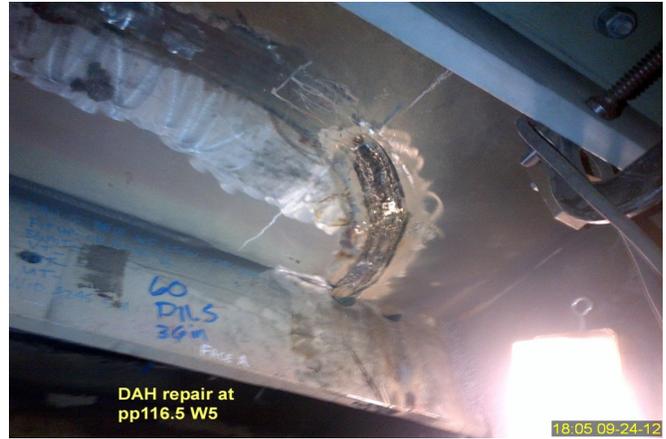
At 1630 hours, the QAI was tasked with monitoring the welding and repairs being performed by ABF welder Rick Clayborn, ID 2773. The QAI noted that repairs are in progress in the Deck Access Hole (DAH) on OBG 13W at panel point (pp) 116.5. The QAI noted that the welding is being monitored by the Quality Control Inspector (QCI) Chris Concha. The QAI noted that the Complete Joint Penetration (CJP) groove weld is being repaired from the bottom in the overhead (4G) position. The QAI also noted that this is a first time repair and the full length of the weld will be repaired using approved weld repair RWR 201208-076. The QAI noted that welding procedure specification (WPS) ABF-WPS-D15-1004-Repair is being utilized. The QAI noted that during the welding, the preheat and interpass temperatures were maintained and the welding parameters were within the ranges listed on the WPS. At the end of the shift, the QAI noted that the electrical induction heating blanket was programmed to maintain the post weld heat of 425F as required and this was in progress at the end of the shift. See the attached photos.
