**DEPARTMENT OF TRANSPORTATION**

Contract #: 04-0120F4Cty: SF/ALA Rte: 80 PM: 13.2/13.9File #: 1.28**WELDING INSPECTION REPORT****Resident Engineer:** Casey, William**Address:** 333 Burma Road**City:** Oakland, CA 94607**Report No:** WIR-028495**Date Inspected:** 25-Sep-2012**Project Name:** SAS Superstructure**OSM Arrival Time:** 700**Prime Contractor:** American Bridge/Fluor Enterprises, a JV**OSM Departure Time:** 1930**Contractor:** American Bridge/Fluor Enterprises, a JV**Location:** Job Site**CWI Name:** William Sherwood**CWI Present:** Yes No**Inspected CWI report:** Yes No N/A**Rod Oven in Use:** Yes No N/A**Electrode to specification:** Yes No N/A**Weld Procedures Followed:** Yes No N/A**Qualified Welders:** Yes No N/A**Verified Joint Fit-up:** Yes No N/A**Approved Drawings:** Yes No N/A**Approved WPS:** Yes No N/A**Delayed / Cancelled:** Yes No N/A**Bridge No:** 34-0006**Component:** SAS OBG**Summary of Items Observed:**

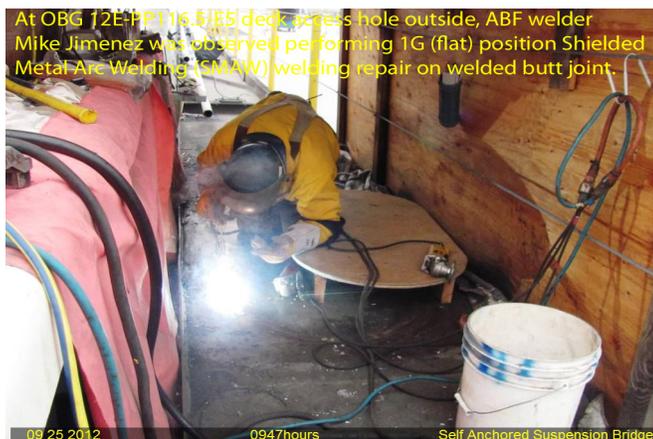
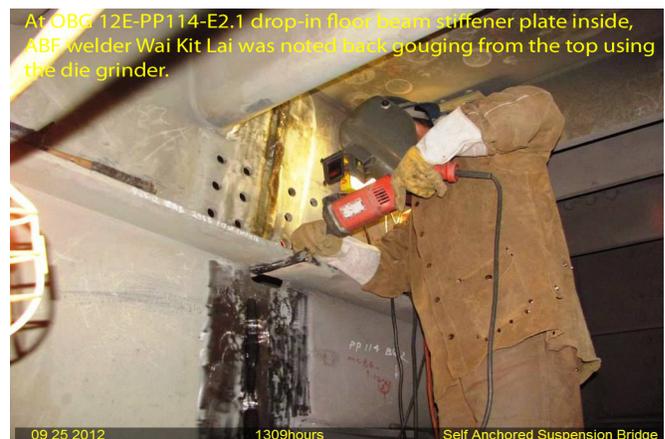
At OBG 12E-PP116.5-E5 deck access hole outside, QA randomly observed ABF/JV qualified welder Mike Jimenez continuing to perform CJP groove welding repair on a Seismic Performance Critical Member (SPCM) due to Ultrasonic Testing (UT) detected defect on welded splice butt joint. The welder preheated the repair area and its vicinity to >225°F using propylene gas torch prior excavation and then ground smooth the groove of the excavation. After its completion, ABF QC William Sherwood performed Magnetic Particle Testing (MT) on the removal of the defects with no relevant defect noted during the test. This QA also performed same test verification and noted same result.

The welder was noted using propylene gas torch to preheat the repair area and its vicinity to 325°F and as soon as the required temperature was attained the welder started performing the welding repair. Welder Mike Jimenez was observed manually welding in 1G (flat) position utilizing Shielded Metal Arc Welding (SMAW) with 3.2mm and 4.0mm diameter E7018H4R electrode implementing Caltrans approved welding procedure ABF-WPS-D15-1004 Repair. Welder Mike Jimenez was noted welding at location Y=600mm to Y=1500mm. During welding, ABF QC William Sherwood was noted monitoring the welder's welding parameter with measured working current of 130 amperes on the 3.2mm and 195 amperes on 4.0mm diameter E7018H4R electrodes. At the end of the shift, repair welding at the location mentioned above was still continuing and the welder has held performed the post weld heat treatment of 450°F on the completed repair using the Miller Proheat 35 Induction Heating System and held it for

At OBG 13E-PP114-E2.1 PS1 floor beam plate stiffener inside, QA randomly observed ABF welder Wai Kit Lai perform 4G/1G (overhead/flat) positions on stiffener complete joint penetration (CJP) splice butt joint. First, the welder was noted welding at 4G position using Shielded Metal Arc Welding (SMAW) with 3.2mm diameter, E7018H4R electrode implementing Caltrans approved Welding Procedure Specification (WPS) ABF-WPS-D15-1030. The joint being welded had a single V-groove butt joint with 60 degree inclusive angle. After welding from one side (bottom side) of the plate, the welder has back gouged the other side using disc and die grinder. After the completion of the back gouging, the welder performed back welding from the top using the same process. During welding, ABF Quality Control (QC) William Sherwood was noted monitoring the welding parameters of the welder. At the end of the shift, CJP welding of the splice butt joint mentioned above was completed.
