DEPARTMENT OF TRANSPORTATION

Contract #: 04-0120F4Cty: SF/ALA Rte: 80 PM: 13.2/13.9File #: 1.28**WELDING INSPECTION REPORT****Resident Engineer:** Casey, William**Address:** 333 Burma Road**City:** Oakland, CA 94607**Report No:** WIR-028496**Date Inspected:** 25-Sep-2012**Project Name:** SAS Superstructure**OSM Arrival Time:** 700**Prime Contractor:** American Bridge/Fluor Enterprises, a JV**OSM Departure Time:** 1930**Contractor:** American Bridge/Fluor Enterprises, a JV**Location:** jobsite**CWI Name:** Barry Drake**CWI Present:** Yes No**Inspected CWI report:** Yes No N/A**Rod Oven in Use:** Yes No N/A**Electrode to specification:** Yes No N/A**Weld Procedures Followed:** Yes No N/A**Qualified Welders:** Yes No N/A**Verified Joint Fit-up:** Yes No N/A**Approved Drawings:** Yes No N/A**Approved WPS:** Yes No N/A**Delayed / Cancelled:** Yes No N/A**Bridge No:** 34-0006**Component:** OBG**Summary of Items Observed:**

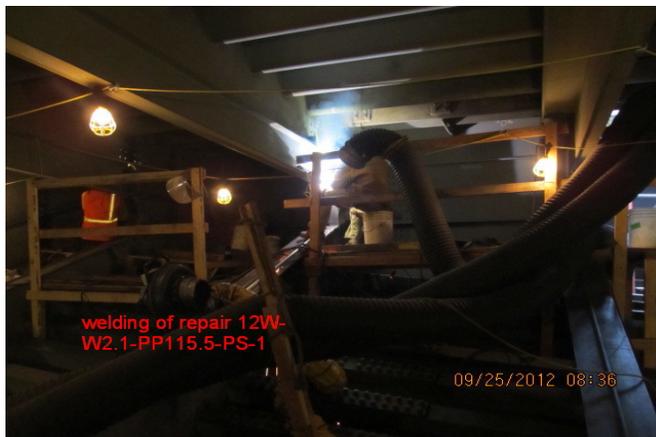
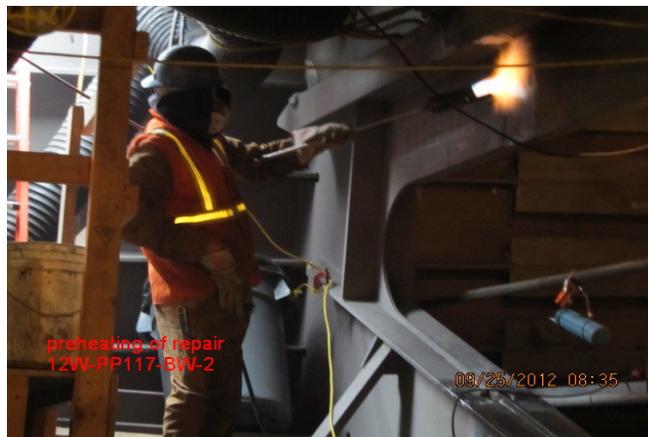
12W-PP115.5-PS-1

This QAI observed the welder Jin Pei Wang performing first time weld repairs at the following location(s) on floor beam 12W-PP115.5-PS-1:

Y=50mm, L=50mm, D=12mm, W=15mm

Prior to welding Quality Control Technician Barry Drake performed Visual and Magnetic Particle Testing on the above excavations. This Quality Assurance Inspector verified the results of the test by doing duplicate testing to the excavations. No indications were noted.

The welder spent part of the shift depositing the root passes and fill passes with approximately 100% being completed at the end of the shift. QC inspector Drake was noted to be present in order to monitor the progress and ensure the welding was within the established Welding Procedure Specification (WPS) noted as ABF-WPS-D15-1001 Rev 0 and supporting Procedure Qualification Records (PQR). Prior to and during the welding at this location the QC inspector observed the preheat temperature using a Raytek non-contact

Thermometer, was sufficient and compliant to the above-mentioned WPS. Using a Tempil Stick, (temperature indicating crayon) the pre-heat was then verified by this QA inspector to be greater than 150F. Using a Fluke brand Tong style meter, the parameters were verified to be 128 amps.
