DEPARTMENT OF TRANSPORTATION

Contract #: 04-0120F4Cty: SF/ALA Rte: 80 PM: 13.2/13.9File #: 1.28**WELDING INSPECTION REPORT****Resident Engineer:** Casey, William**Address:** 333 Burma Road**City:** Oakland, CA 94607**Report No:** WIR-028502**Date Inspected:** 27-Sep-2012**Project Name:** SAS Superstructure**OSM Arrival Time:** 700**Prime Contractor:** American Bridge/Fluor Enterprises, a JV**OSM Departure Time:** 1530**Contractor:** American Bridge/Fluor Enterprises, a JV**Location:** Job Site

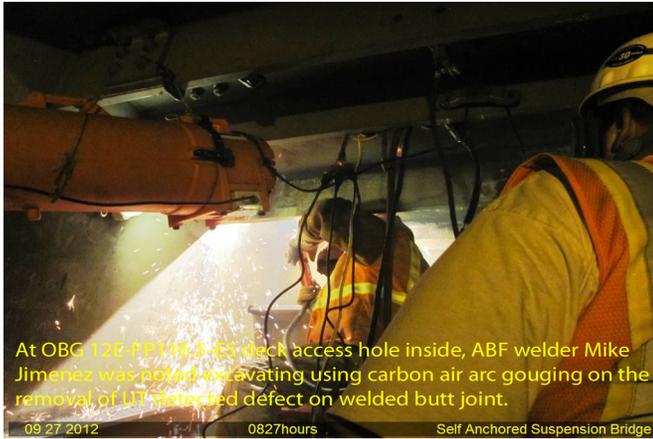
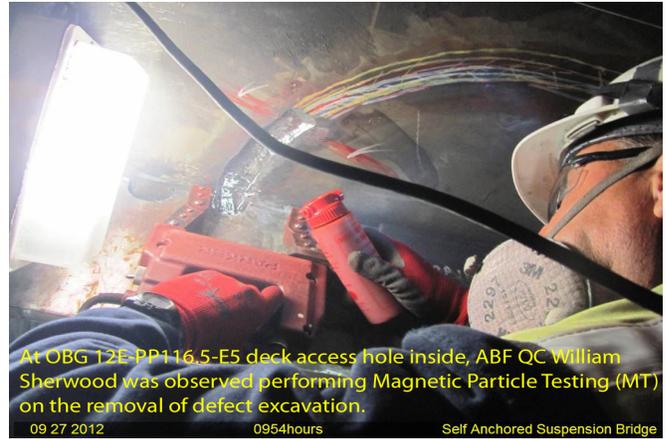
At OBG 12E-PP116.5-E5 deck access hole inside, QA randomly observed ABF/JV qualified welder Mike Jimenez continuing to perform CJP groove welding repair on a Seismic Performance Critical Member (SPCM) due to Ultrasonic Testing (UT) detected defect on welded butt joint. The welder preheated the repair area and its vicinity to >225°F using propylene gas torch prior excavation and then ground smooth the groove of the excavation. After its completion, ABF QC William Sherwood performed Magnetic Particle Testing (MT) on the removal of the defects with no relevant defect noted during the test. This QA also performed same test verification and noted same result.

The welder was Miller Proheat 35 Induction Heating System with the heater blanket put on top of the plate to preheat the repair area and its vicinity to 325°F and as soon as the required temperature was attained the welder started performing the welding repair. Welder Mike Jimenez was observed manually welding in 4G (vertical) position utilizing Shielded Metal Arc Welding (SMAW) with 3.2mm and 4.0mm diameter E7018H4R electrode implementing Caltrans approved welding procedure ABF-WPS-D15-1004 Repair. Welder Mike Jimenez was noted welding at location Y=3140mm to Y=4070mm. During welding, ABF QC William Sherwood was noted monitoring the welder's welding parameter with measured working current of 130 amperes on the 3.2mm and 195 amperes on 4.0mm diameter E7018H4R electrodes. At the end of the shift, repair welding at the location mentioned above was still continuing and the welder has performed the post weld heat treatment of 450°F on the
