DEPARTMENT OF TRANSPORTATION

Contract #: 04-0120F4Cty: SF/ALA Rte: 80 PM: 13.2/13.9File #: 1.28**WELDING INSPECTION REPORT****Resident Engineer:** Casey, William**Address:** 333 Burma Road**City:** Oakland, CA 94607**Report No:** WIR-028509**Date Inspected:** 28-Sep-2012**Project Name:** SAS Superstructure**OSM Arrival Time:** 700**Prime Contractor:** American Bridge/Fluor Enterprises, a JV**OSM Departure Time:** 1930**Contractor:** American Bridge/Fluor Enterprises, a JV**Location:** Job Site**CWI Name:** John Hays and Bernie Docena**CWI Present:** Yes No**Inspected CWI report:** Yes No N/A**Rod Oven in Use:** Yes No N/A**Electrode to specification:** Yes No N/A**Weld Procedures Followed:** Yes No N/A**Qualified Welders:** Yes No N/A**Verified Joint Fit-up:** Yes No N/A**Approved Drawings:** Yes No N/A**Approved WPS:** Yes No N/A**Delayed / Cancelled:** Yes No N/A**Bridge No:** 34-0006**Component:** SAS OBG**Summary of Items Observed:**

WELDING INSPECTION REPORT

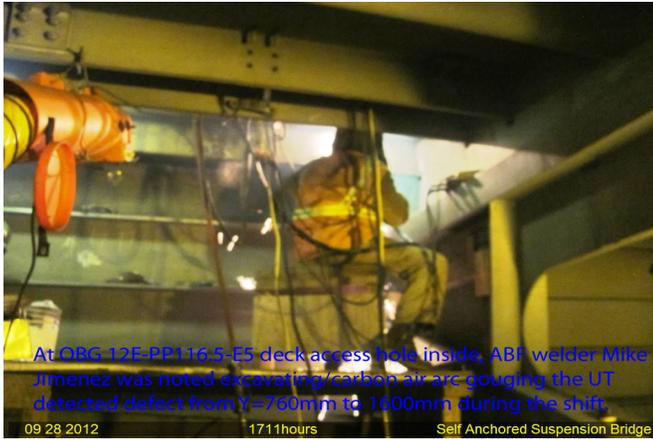
At OBG 12E-PP116.5-E5 deck access hole inside, QA randomly observed ABF/JV qualified welder Mike Jimenez continuing to perform CJP groove welding repair on a Seismic Performance Critical Member (SPCM) due to Ultrasonic Testing (UT) detected defect on welded butt joint. The welder was using Miller Proheat 35 Induction Heating System with the heater blanket put on top of the plate to preheat the repair area and its vicinity to 325°F and as soon as the required temperature was attained the welder started performing the welding repair. Welder Mike Jimenez was observed manually welding in 4G (overhead) position utilizing Shielded Metal Arc Welding (SMAW) with 3.2mm and 4.0mm diameter E7018H4R electrode implementing Caltrans approved welding procedure ABF-WPS-D15-1004 Repair. Welder Mike Jimenez was noted welding at location Y=3140mm to Y=4070mm. During welding, ABF QC John Hays was noted monitoring the welder's welding parameter with measured working current of 130 amperes on the 3.2mm and 195 amperes on 4.0mm diameter E7018H4R electrodes. During the shift, repair welding at the location mentioned above was completed and the welder has performed the post weld heat treatment (PWHT) of 450°F on the completed repair using the Miller Proheat 35 Induction Heating System and held it for one hour as required. After setting the PWHT of the just concluded repair, using a propylene gas torch to preheat the repair area and its vicinity to 225°F, the welder started excavating using carbon air arc gouging on the next repair at Y=760mm of the same access hole. The welder performed the excavation until the end of the shift.
