Contract #: 04-0120F4Cty: SF/ALA Rte: 80 PM: 13.2/13.9File #: 1.28**WELDING INSPECTION REPORT****Resident Engineer:** Casey, William**Address:** 333 Burma Road**City:** Oakland, CA 94607**Report No:** WIR-028513**Date Inspected:** 29-Sep-2012**Project Name:** SAS Superstructure**OSM Arrival Time:** 700**Prime Contractor:** American Bridge/Fluor Enterprises, a JV**OSM Departure Time:** 1530**Contractor:** American Bridge/Fluor Enterprises, a JV**Location:** Job site**CWI Name:** Harry Scharein**CWI Present:** Yes No**Inspected CWI report:** Yes No N/A**Rod Oven in Use:** Yes No N/A**Electrode to specification:** Yes No N/A**Weld Procedures Followed:** Yes No N/A**Qualified Welders:** Yes No N/A**Verified Joint Fit-up:** Yes No N/A**Approved Drawings:** Yes No N/A**Approved WPS:** Yes No N/A**Delayed / Cancelled:** Yes No N/A**Bridge No:** 34-0006**Component:** OBG**Summary of Items Observed:**

Magnetic Particle Testing (OBG 13W)

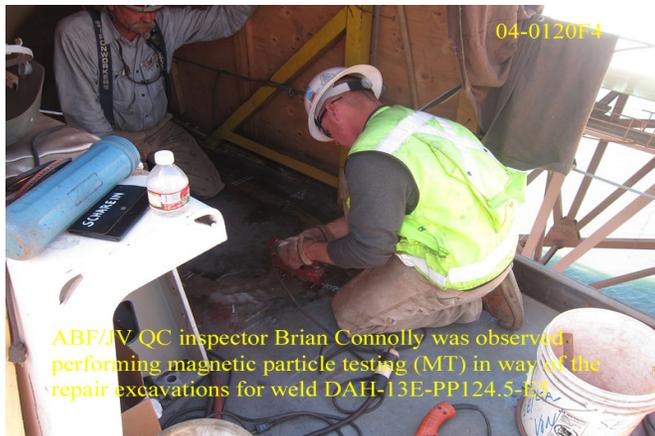
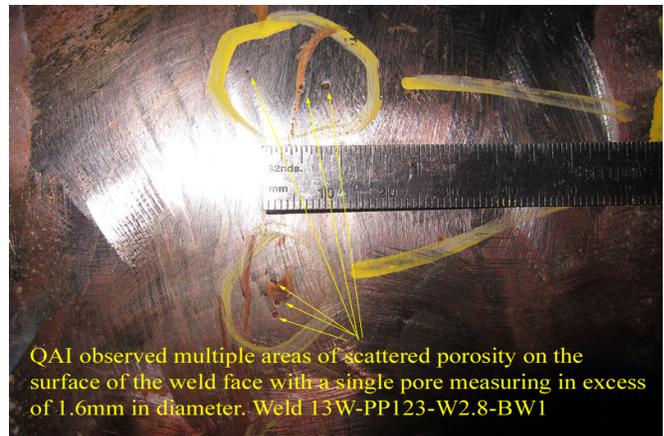
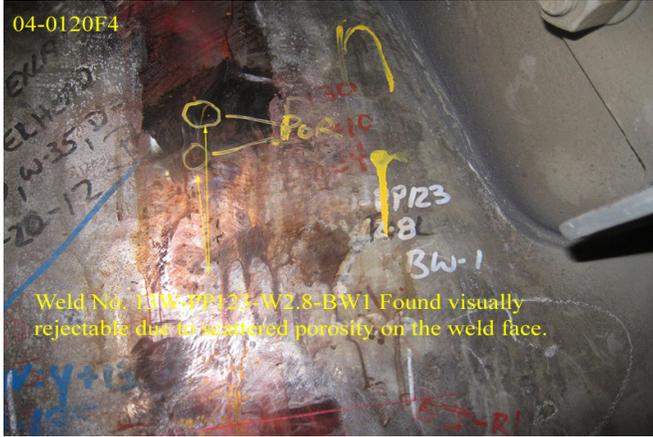
During the QA visual inspection prior to magnetic particle testing the QAI observed multiple areas of scattered porosity on the surface of the weld face with a single pore measuring in excess of 1.6mm in diameter. Further repair at this location is required prior to QA acceptance.

The QAI observed ABF/JV qualified welder Erick Sparks #3040 performing Carbon Arc Gouging (CAG) for the repair of the deck access hole weld designated as DAH-13E-PP124.5-E5. The ABF/JV QC inspector Brian Connolly was observed performing magnetic particle testing (MT) in way of the repair excavations at the following locations,

The repairs at this location were only excavated during the QAI's shift and will require welding at a later date.
