DEPARTMENT OF TRANSPORTATION

Contract #: 04-0120F4Cty: SF/ALA Rte: 80 PM: 13.2/13.9File #: 1.28**WELDING INSPECTION REPORT****Resident Engineer:** Casey, William**Address:** 333 Burma Road**City:** Oakland, CA 94607**Report No:** WIR-028519**Date Inspected:** 06-Oct-2012**Project Name:** SAS Superstructure**OSM Arrival Time:** 700**Prime Contractor:** American Bridge/Fluor Enterprises, a JV**OSM Departure Time:** 1530**Contractor:** American Bridge/Fluor Enterprises, a JV**Location:** Job site

Bridge No: 34-0006**Component:** OBG**Summary of Items Observed:**

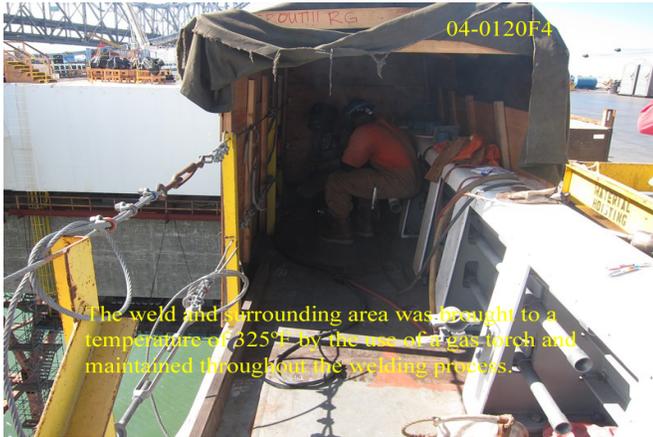
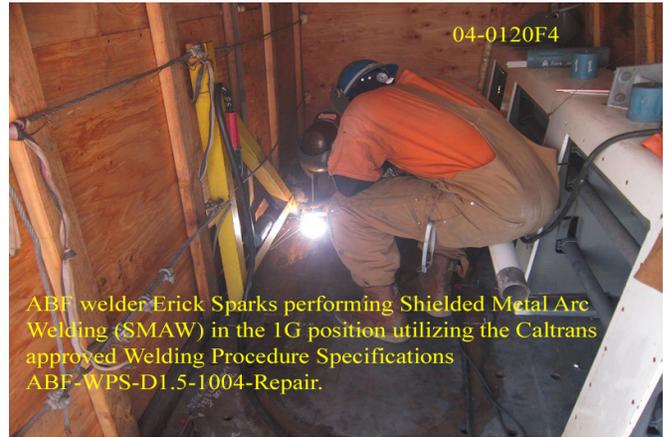
The QAI observed ABF/JV qualified welder Rick Clayborn #2773 performing Carbon Arc Gouging (CAG) for the repair of the longitudinal deck drop-in weld designated as 13W-W2.1. The ABF/JV QC inspector Chris Concha was observed performing magnetic particle testing (MT) in way of the repair excavations at the following locations,

13W-W2.1

Y=2480, Depth 12, Width 55mm, Length 150mm

Y=2740, Depth 13, Width 35mm, Length 150mm

The ABF qualified welder Rick Clayborn #2773 was observed later in the shift performing Shielded Metal Arc Welding (SMAW) in the 4G position utilizing the Caltrans approved Welding Procedure Specifications ABF-WPS-D1.5-1004-Repair at the above mentioned location. The weld and surrounding area was brought to a temperature of 325°F by the use of induction heaters and maintained throughout the welding process. The repairs were then observed to be post heated at 450°F for one hour as required by the applicable repair document. The weld repairs were performed in accordance with approval for repair document RWR201209-110 for Y=2480 and RWR201209-106 for Y=2740.

The QAI noted and periodically observed ABF welder Erick Sparks performing Shielded Metal Arc Welding (SMAW) in the 1G position utilizing the Caltrans approved Welding Procedure Specifications ABF-WPS-D1.5-1004-Repair. The repairs are located on the deck access hole drop-in weld for lift 13W between panel point 124 and 124.5 at the following locations;

Y=2700 Depth 8, Width 16mm, Length 50mm

The weld and surrounding area was brought to a temperature of 325°F by the use of a gas torch and maintained throughout the welding process. The repairs were then observed to be post heated at 450°F for one hour. The repair excavations were performed in accordance with approval for repair documents 201210-006.
