DEPARTMENT OF TRANSPORTATION

Contract #: 04-0120F4Cty: SF/ALA Rte: 80 PM: 13.2/13.9File #: 1.28**WELDING INSPECTION REPORT****Resident Engineer:** Casey, William**Address:** 333 Burma Road**City:** Oakland, CA 94607**Report No:** WIR-028522**Date Inspected:** 03-Oct-2012**Project Name:** SAS Superstructure**OSM Arrival Time:** 700**Prime Contractor:** American Bridge/Fluor Enterprises, a JV**OSM Departure Time:** 1730**Contractor:** American Bridge/Fluor Enterprises, a JV**Location:** Job site

Bridge No: 34-0006**Summary of Items Observed:**

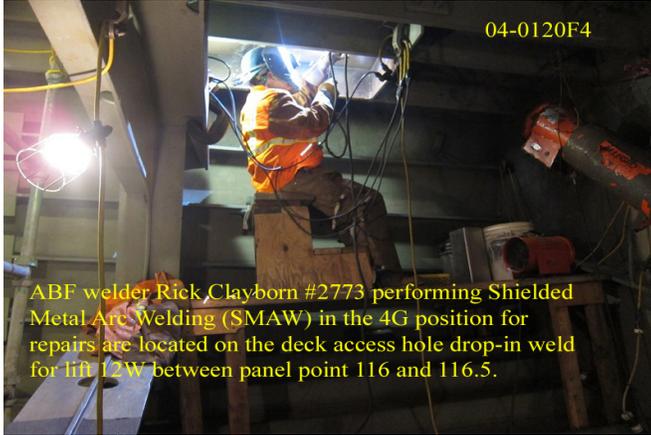
The QAI noted and periodically observed ABF welder Rick Clayborn #2773 performing Shielded Metal Arc Welding (SMAW) in the 4G position utilizing the Caltrans approved Welding Procedure Specifications ABF-WPS-D1.5-1004-Repair. The weld designated as DAH-12W-PP116.5-W5 was excavated and magnetic particle testing performed on a previous shift. The repairs are located on the deck access hole drop-in weld for lift 12W between panel point 116 and 116.5 at the following locations;

Y=0 Depth 11.5, Width 55mm, Length 780mm

The weld and surrounding area was brought to a temperature of 325°F by the use of induction heaters and maintained throughout the welding process. The repairs were then observed to be post heated at 450°F for one hour as required by the applicable repair document. The repair excavations were performed in accordance with approval for repair document RWR201208-76.
