**DEPARTMENT OF TRANSPORTATION**

Contract #: 04-0120F4Cty: SF/ALA Rte: 80 PM: 13.2/13.9File #: 1.28**WELDING INSPECTION REPORT****Resident Engineer:** Casey, William**Address:** 333 Burma Road**City:** Oakland, CA 94607**Report No:** WIR-028527**Date Inspected:** 05-Oct-2012**Project Name:** SAS Superstructure**OSM Arrival Time:** 700**Prime Contractor:** American Bridge/Fluor Enterprises, a JV**OSM Departure Time:** 1730**Contractor:** American Bridge/Fluor Enterprises, a JV**Location:** Job Site

## WELDING INSPECTION REPORT

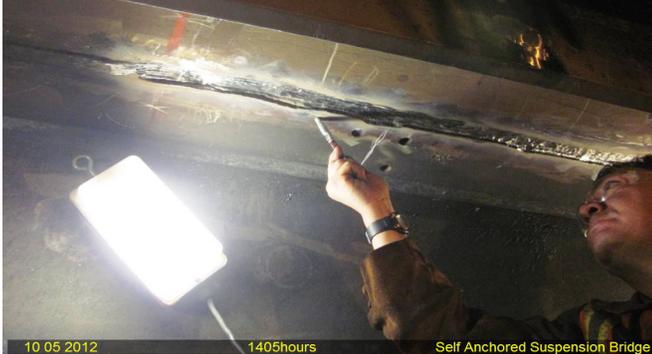
At OBG 12E-PP116.5-E5 deck access hole inside, ABF welder Mike Jimenez was noted checking the preheat using a 325 degree temperature crayon during repair welding of the welded butt joint

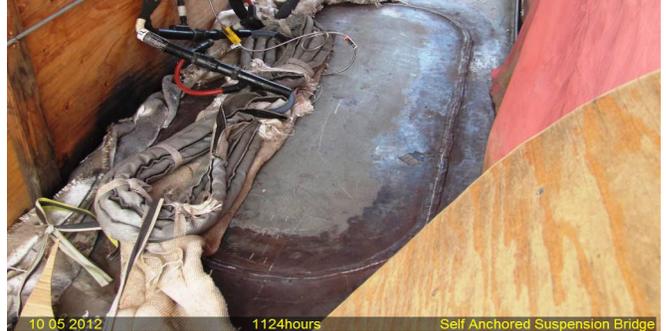
At OBG 12E-PP116.5 E5 deck access hole, ABF personnel were noted using the Miller Proheat 35 Induction Heating System to preheat and maintain the required temperature of 325 degrees Fahrenheit during SMAW repair welding.

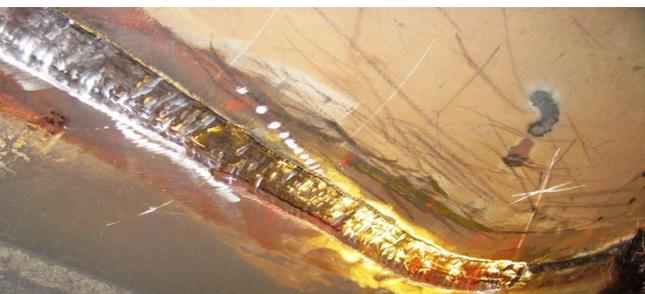
At OBG 12E-PP116.5-E5 deck access hole inside, surface profile of the repair excavation from the bottom was noted approximately 1000mm long x 52mm wide x 12mm deep. The groove of the excavation was noted ground and ABF QC William Sherwood performed the Magnetic Particle Testing (MT) on the excavation.

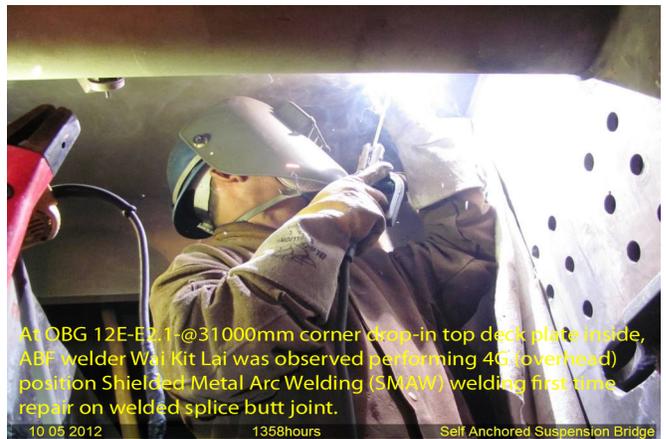
At OBG 12E-E2.1 @31000mm corner drop-in top deck plate inside, ABF welder Wai Kit Lai was observed performing 4G (overhead) position Shielded-Metal Arc Welding (SMAW) welding first time repair on welded splice butt joint.
