**DEPARTMENT OF TRANSPORTATION**

Contract #: 04-0120F4Cty: SF/ALA Rte: 80 PM: 13.2/13.9File #: 1.28**WELDING INSPECTION REPORT****Resident Engineer:** Casey, William**Address:** 333 Burma Road**City:** Oakland, CA 94607**Report No:** WIR-028545**Date Inspected:** 09-Oct-2012**Project Name:** SAS Superstructure**OSM Arrival Time:** 700**Prime Contractor:** American Bridge/Fluor Enterprises, a JV**OSM Departure Time:** 1730**Contractor:** American Bridge/Fluor Enterprises, a JV**Location:** Job Site

# WELDING INSPECTION REPORT

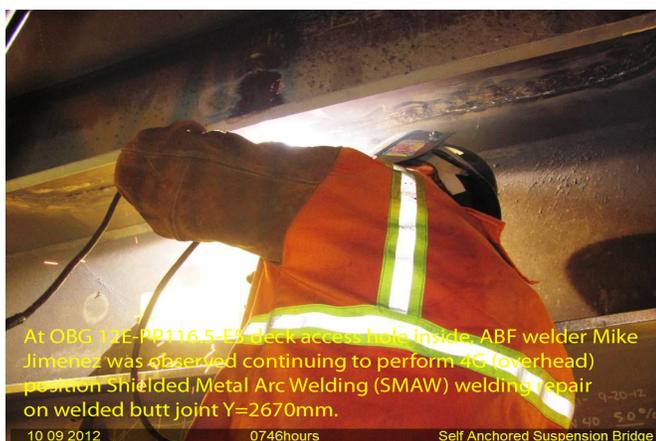
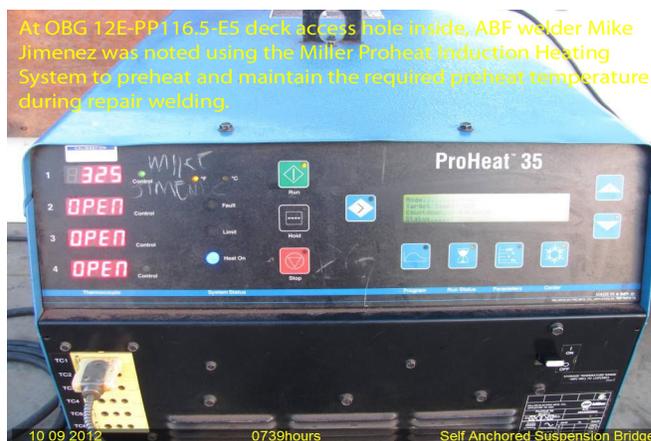
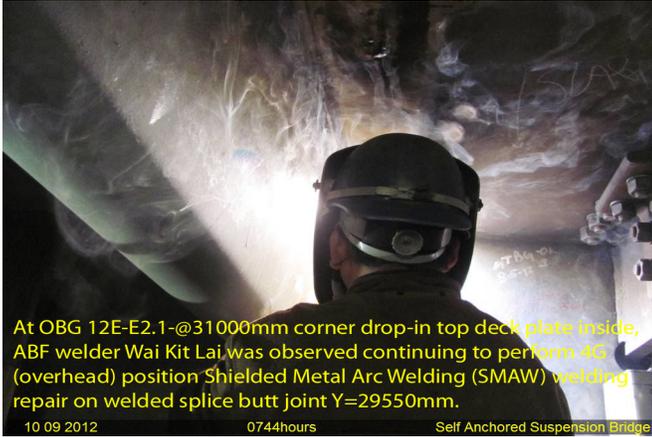
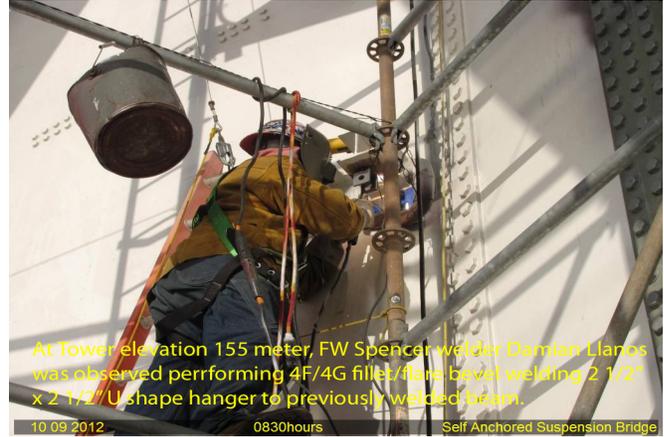
At OBG 12E-PP116.5-E5 deck access hole inside, QA randomly observed ABF/JV qualified welder Mike Jimenez continuing to perform CJP groove welding repair on a Seismic Performance Critical Member (SPCM) due to Ultrasonic Testing (UT) detected defect on welded butt joint. The welder was using Miller Proheat 35 Induction Heating System with the heater blanket put on top of the plate to preheat the repair area and its vicinity to 325°F and as soon as the required temperature was attained the welder started performing the welding repair. Welder Mike Jimenez was observed manually welding in 4G (overhead) position utilizing Shielded Metal Arc Welding (SMAW) with 3.2mm diameter E7018H4R electrode implementing Caltrans approved welding procedure ABF-WPS-D15-1004 Repair. During welding, ABF QC Salvador Merino was noted monitoring the welder's welding parameter with measured working current of 132 amperes on the 3.2mm diameter E7018H4R electrodes. At the end of the shift, the repair welding at the location mentioned above was still continuing and the welder performed the post weld heat treatment (PWHT) of 450°F on the ongoing repair using the Miller Proheat 35 Induction Heating System and held it for one hour as required.

At OBG 12E-E2.1-@31000mm corner drop-in top deck plate inside, QA randomly observed ABF/JV qualified welder Wai Kit Lai continuing to perform CJP groove welding first time repair on a non-Seismic Performance Critical Member (SPCM) due to Ultrasonic Testing (UT) detected defect on welded splice butt joint. The welder was noted using propylene gas torch to preheat the repair area and its vicinity to >150°F and as soon as the required temperature was attained the welder started performing the welding repair. Welder Wai Kit Lai was observed manually welding in 4G (overhead) position utilizing Shielded Metal Arc Welding (SMAW) with 3.2mm diameter E7018H4R electrode implementing Caltrans approved welding procedure ABF-WPS-D15-1000 Repair Rev. 2. During welding, ABF QC Salvador Merino was noted monitoring the welder's welding parameter with measured working current of 126 amperes on the 3.2mm diameter E7018H4R electrodes. During the shift, repair welding at the location listed below were noted;

After the completion of the above mentioned repair, the welder has moved to another location corner drop-in floor beam 12E-PP112.5-E2.1 BW2 and also performed repair welding. The welder was noted welding repair at the web splice butt joint at Y=1400mm having excavation dimensions of 70mm long x 15mm wide x 6mm deep. The welder was also noted using Shielded Metal arc Welding with 3.2mm diameter E7018H4R electrode implementing Caltrans approved welding procedure ABF-WPS-D15-1000 Repair Rev. 2. At the end of the shift, this repair was also completed.

At Tower location elevation 155 meters, this QA randomly observed FW Spencer qualified welder Damian Llanos continuing to perform ¼" fillet/flare bevel welding all around the 2 1/2" x 2 ½" U shape hanger to the previously welded beam attached to the Tower. The welder was noted using 3/32" diameter E7018H4R electrode. ABF QC Barry Drake was also noted monitoring the welded with measured working current of 90 amps on 3/32" diameter E7018H4R electrode.
