DEPARTMENT OF TRANSPORTATION

Quality Assurance and Source Inspection

WELDING INSPECTION REPORT

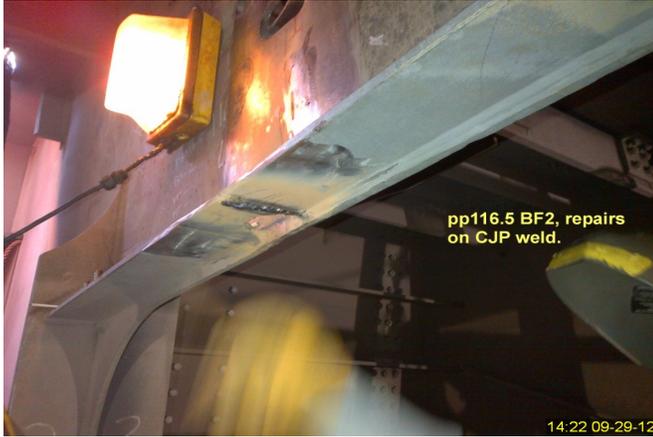
The QAI was tasked with monitoring the welding and repairs being performed on the Complete Joint Penetration (CJP) groove welds on the OBG 12E corner assembly. At panel point (pp)116.5, the QAI observed ABF welder Deli Zhang, ID 4735, welding repairs on the Bottom Web (BW)2 and Bottom Flange (BF)2. The QAI noted that the welding is being monitored by the Quality Control Inspector (QCI) Steve Jensen. Throughout the shift, the QAI made random observations of the work in progress. During the observations of the welding, the preheat and interpass temperatures were maintained and the welding parameters were within the ranges listed on Welding Procedure Specification (WPS) ABF-WPS-D15-1000-Repair. See the attached photo. The QAI noted that the work was not completed at the end of the shift.

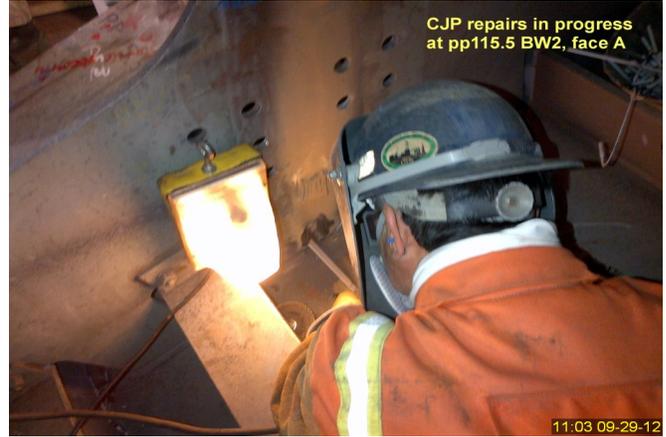
At pp115.5, the QAI observed ABF welders Xiao Hua Luo, ID 1291, and James Zhen, ID 6001, welding repairs on face A and face B of BW2 and BF3. The QAI noted that this welding is also being monitored by the QCI Steve Jensen. Throughout the shift, the QAI made random observations of the work in progress. During the observations of the welding, the preheat and interpass temperatures were maintained and the welding parameters were within the ranges listed on Welding Procedure Specification (WPS) ABF-WPS-D15-1000-Repair. See the attached photo. The QAI noted that the work was not completed at the end of the shift.
