DEPARTMENT OF TRANSPORTATION

Contract #: 04-0120F4Cty: SF/ALA Rte: 80 PM: 13.2/13.9File #: 1.28**WELDING INSPECTION REPORT****Resident Engineer:** Casey, William**Address:** 333 Burma Road**City:** Oakland, CA 94607**Report No:** WIR-028553**Date Inspected:** 28-Sep-2012**Project Name:** SAS Superstructure**OSM Arrival Time:** 700**Prime Contractor:** American Bridge/Fluor Enterprises, a JV**OSM Departure Time:** 1900**Contractor:** American Bridge/Fluor Enterprises, a JV**Location:** jobsite

Bridge No: 34-0006**Component:** OBG**Summary of Items Observed:**

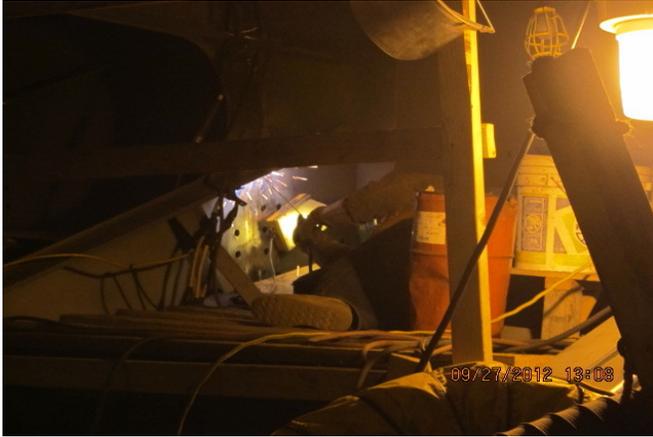
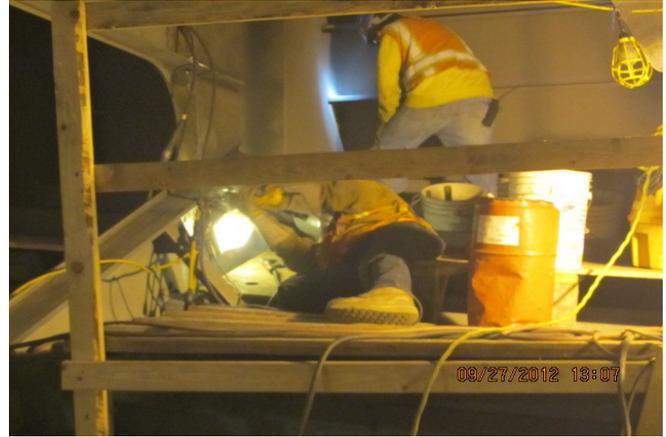
This QAI from time to time observed the welder Lin E Yun grinding to a bright clean metal condition an excavation at the following location on Floor Beam Bottom Flange Splice 13W-PP113.5-W2.2-BW-3:

Y=40mm, D=10mm, L=80mm, W=40mm

Y=170mm, D=10mm, L=70mm, W=40mm
