Contract #: 04-0120F4Cty: SF/ALA Rte: 80 PM: 13.2/13.9File #: 1.28**WELDING INSPECTION REPORT****Resident Engineer:** Casey, William**Address:** 333 Burma Road**City:** Oakland, CA 94607**Report No:** WIR-028562**Date Inspected:** 02-Oct-2012**Project Name:** SAS Superstructure**OSM Arrival Time:** 700**Prime Contractor:** American Bridge/Fluor Enterprises, a JV**OSM Departure Time:** 1730**Contractor:** American Bridge/Fluor Enterprises, a JV**Location:** Job site**CWI Name:** Harry Scharein**CWI Present:** Yes No**Inspected CWI report:** Yes No N/A**Rod Oven in Use:** Yes No N/A**Electrode to specification:** Yes No N/A**Weld Procedures Followed:** Yes No N/A**Qualified Welders:** Yes No N/A**Verified Joint Fit-up:** Yes No N/A**Approved Drawings:** Yes No N/A**Approved WPS:** Yes No N/A**Delayed / Cancelled:** Yes No N/A**Bridge No:** 34-0006**Component:** OBG**Summary of Items Observed:**

OBG 13E Deck Drop-in (13W-W2.3)

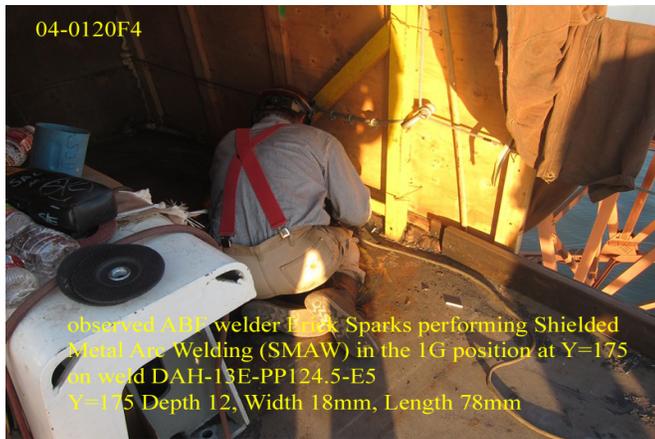
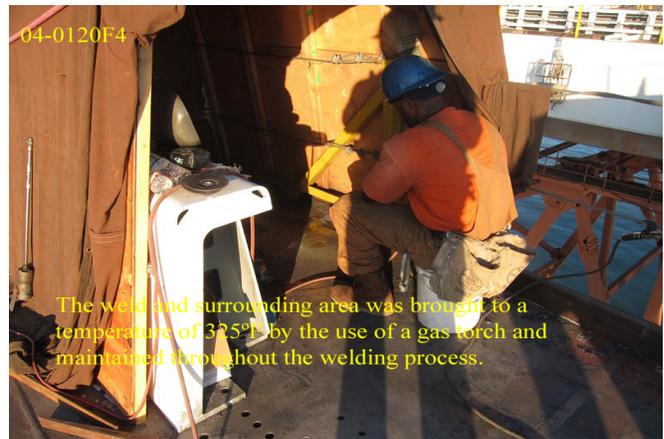
This QA randomly observed ABF/JV QC inspector Patrick Swain performing Ultrasonic Testing (UT) of the deck drop-in longitudinal seam designated as 13W-W2.3. The locations Ultrasonically tested were in way of repairs performed and completed 24 hours prior. The following locations were tested;

Y=1170 A total of two (2) rejectable indications were observed by QC at this repair location.

The QAI noted and periodically observed ABF welder Erick Sparks performing Shielded Metal Arc Welding (SMAW) in the 1G position utilizing the Caltrans approved Welding Procedure Specifications ABF-WPS-D1. 5-1004-Repair. The weld was excavated and magnetic particle testing performed on a previous shift. The repairs are located on the deck access hole drop-in weld for lift 13E between panel point 124 and 124.5 at the following locations;

Y=175 Depth 12, Width 18mm, Length 78mm

The weld and surrounding area was brought to a temperature of 325°F by the use of a gas torch and maintained throughout the welding process. The repairs were then observed to be post heated at 450°F for one hour. The repair excavations were performed in accordance with the following approval for repair document RWR201209-124.
