DEPARTMENT OF TRANSPORTATION

Contract #: 04-0120F4Cty: SF/ALA Rte: 80 PM: 13.2/13.9File #: 1.28**WELDING INSPECTION REPORT****Resident Engineer:** Casey, William**Address:** 333 Burma Road**City:** Oakland, CA 94607**Report No:** WIR-028568**Date Inspected:** 10-Oct-2012**Project Name:** SAS Superstructure**OSM Arrival Time:** 700**Prime Contractor:** American Bridge/Fluor Enterprises, a JV**OSM Departure Time:** 1730**Contractor:** American Bridge/Fluor Enterprises, a JV**Location:** Job Site

| Bridge No: | 34-0006 | | | Component: | SAS OBG | | |

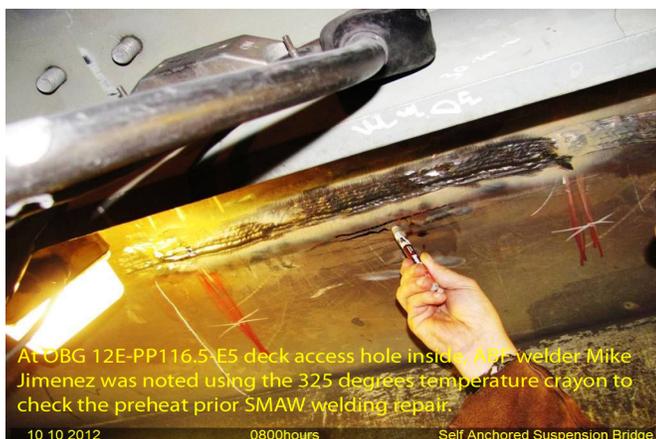
At OBG 12E-PP116.5-E5 deck access hole inside, QA randomly observed ABF/JV qualified welder Mike Jimenez continuing to perform CJP groove welding repair on a Seismic Performance Critical Member (SPCM) due to Ultrasonic Testing (UT) detected defect on welded butt joint. The welder was using Miller Proheat 35 Induction Heating System with the heater blanket put on top of the plate to preheat the repair area and its vicinity to 325°F and as soon as the required temperature was attained the welder started performing the welding repair. Welder Mike Jimenez was observed manually welding in 4G (overhead) position utilizing Shielded Metal Arc Welding (SMAW) with 3.2mm diameter E7018H4R electrode implementing Caltrans approved welding procedure ABF-WPS-D15-1004 Repair. During welding, ABF QC William Sherwood was noted monitoring the welder's welding parameter with measured working current of 130 amperes on the 3.2mm diameter E7018H4R electrodes. During the shift, the repair welding at the location mentioned above was completed and the welder performed the post weld heat treatment (PWHT) of 450°F on the completed repair using the Miller Proheat 35 Induction Heating System and held it for one hour as required.

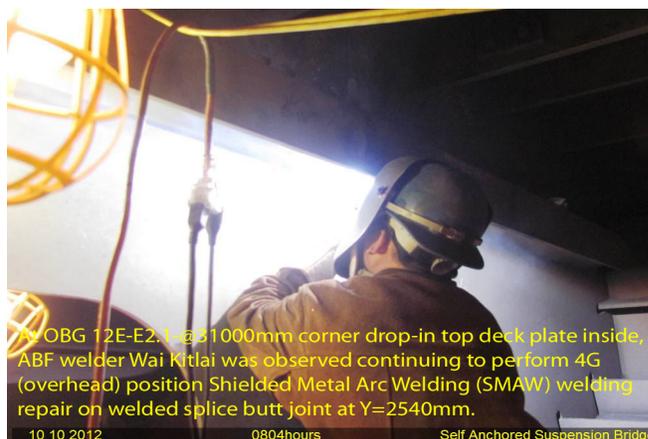
At OBG 12E-E2.1-@31000mm corner drop-in top deck plate inside, QA randomly observed ABF/JV qualified welder Wai Kit Lai continuing to perform CJP groove welding first time repair on a non-Seismic Performance Critical Member (SPCM) due to Ultrasonic Testing (UT) detected defect on welded splice butt joint. The welder was noted using propylene gas torch to preheat the repair area and its vicinity to >150°F and as soon as the required temperature was attained the welder started performing the welding repair. Welder Wai Kit Lai was observed manually welding in 4G (overhead) position utilizing Shielded Metal Arc Welding (SMAW) with 3.2mm diameter E7018H4R electrode implementing Caltrans approved welding procedure ABF-WPS-D15-1000 Repair Rev. 2. During welding, ABF QC William Sherwood was noted monitoring the welder's welding parameter with measured working current of 126 amperes on the 3.2mm diameter E7018H4R electrodes. During the shift, repair welding at the location listed below were noted;
