**DEPARTMENT OF TRANSPORTATION**

Contract #: 04-0120F4Cty: SF/ALA Rte: 80 PM: 13.2/13.9File #: 1.28**WELDING INSPECTION REPORT****Resident Engineer:** Casey, William**Address:** 333 Burma Road**City:** Oakland, CA 94607**Report No:** WIR-028582**Date Inspected:** 09-Oct-2012**Project Name:** SAS Superstructure**OSM Arrival Time:** 700**Prime Contractor:** American Bridge/Fluor Enterprises, a JV**OSM Departure Time:** 1530**Contractor:** American Bridge/Fluor Enterprises, a JV**Location:** S.A.S. Job site

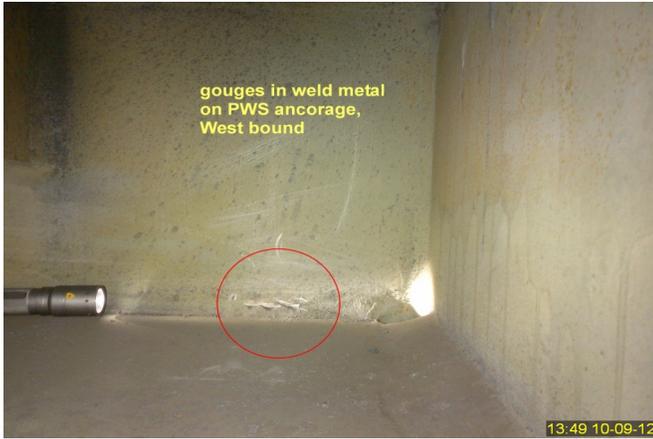
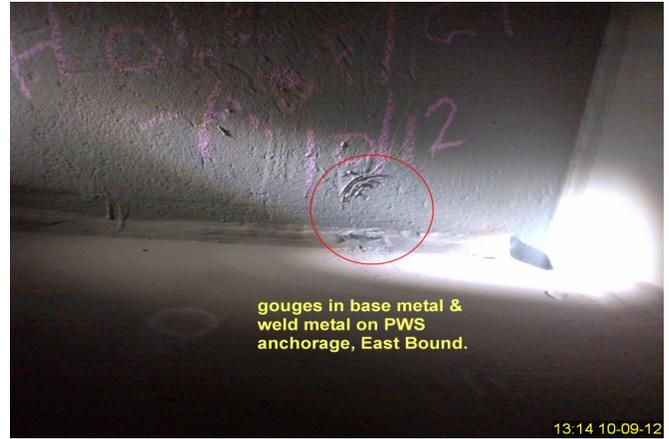
The QAI met with the Assistant Structural Materials Representative (ASMR) Parinaz Aghili and reviewed punchlist item #3654. The QAI then went to the locations specified in the punchlist item to verify what work has been performed by the contractor. The QAI noted that the locations identified for grinding smooth appeared to be smooth with the exception of West bound #1, it could not be identified; West bound #3, is coped into stiffener plate; West bound #4, appears to be a welded repair of the bolt hole (the work does not appear to have been performed at the job site). The QAI also noted that several items were not accessible due to the placement of temporary ducts for ventilation. While the QAI was making the punchlist observations, there were gouges observed in the base / weld metals of the Parallel Wire Strands (PWS) anchorages on the East and West bound sections. The gouges have a circular pattern and cut sharply into the steel. See the attached photos. The QAI noted that additional observations will be needed to finish verifying the punchlist item.
