DEPARTMENT OF TRANSPORTATION

Contract #: 04-0120F4Cty: SF/ALA Rte: 80 PM: 13.2/13.9File #: 1.28**WELDING INSPECTION REPORT****Resident Engineer:** Casey, William**Address:** 333 Burma Road**City:** Oakland, CA 94607**Report No:** WIR-028586**Date Inspected:** 10-Oct-2012**Project Name:** SAS Superstructure**OSM Arrival Time:** 700**Prime Contractor:** American Bridge/Fluor Enterprises, a JV**OSM Departure Time:** 1730**Contractor:** American Bridge/Fluor Enterprises, a JV**Location:** Job site

Bridge No: 34-0006**Summary of Items Observed:**

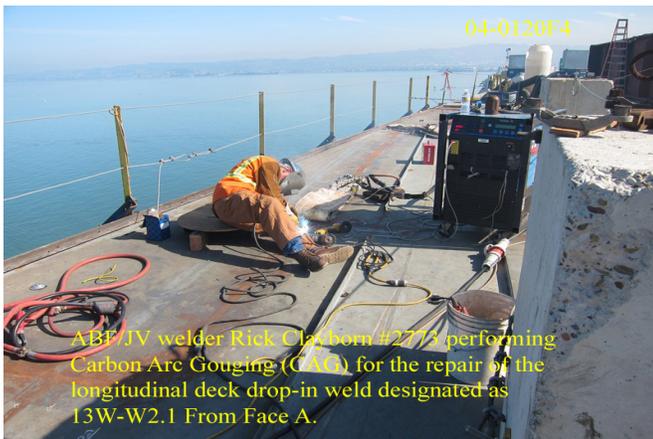
The QAI observed ABF/JV welder Rick Clayborn #2773 performing Carbon Arc Gouging (CAG) for the repair of the longitudinal deck drop-in weld designated as 13W-W2.1 From Face A. The ABF/JV QC inspector Patrick Swain was observed performing magnetic particle testing (MT) in way of the repair excavations at the following locations,

13W-W2.1 (Face A)

Y=2480, Depth 12, Width 70mm, Length 200mm

Y=5180, Depth 12, Width 55mm, Length 120mm

Y=7910, Depth 12, Width 70mm, Length 115mm

Y=9250, Depth 12, Width 70mm, Length 100mm

The ABF welder Rick Clayborn #2773 was observed later in the shift performing Shielded Metal Arc Welding (SMAW) in the 4G position utilizing the Caltrans approved Welding Procedure Specifications ABF-WPS-D1. 5-1004-Repair at the above mentioned location. The weld and surrounding area was brought to a temperature of 325°F by the use of induction heaters and maintained throughout the welding process. The repairs were then observed to be post heated at 450°F for one hour as required by the applicable repair document. The repairs were performed in accordance with the following approval for repair documents;

Y=2480 RWR201209-110
Y=5180 RWR201209-111
Y=7910 RWR201209-112
Y=9250 RWR201209-113
