**DEPARTMENT OF TRANSPORTATION**

Contract #: 04-0120F4Cty: SF/ALA Rte: 80 PM: 13.2/13.9File #: 1.28**WELDING INSPECTION REPORT****Resident Engineer:** Casey, William**Address:** 333 Burma Road**City:** Oakland, CA 94607**Report No:** WIR-028589**Date Inspected:** 13-Oct-2012**Project Name:** SAS Superstructure**OSM Arrival Time:** 700**Prime Contractor:** American Bridge/Fluor Enterprises, a JV**OSM Departure Time:** 1530**Contractor:** American Bridge/Fluor Enterprises, a JV**Location:** Job Site**CWI Name:** William Sherwood**CWI Present:** Yes No**Inspected CWI report:** Yes No N/A**Rod Oven in Use:** Yes No N/A**Electrode to specification:** Yes No N/A**Weld Procedures Followed:** Yes No N/A**Qualified Welders:** Yes No N/A**Verified Joint Fit-up:** Yes No N/A**Approved Drawings:** Yes No N/A**Approved WPS:** Yes No N/A**Delayed / Cancelled:** Yes No N/A**Bridge No:** 34-0006**Component:** SAS OBG**Summary of Items Observed:**

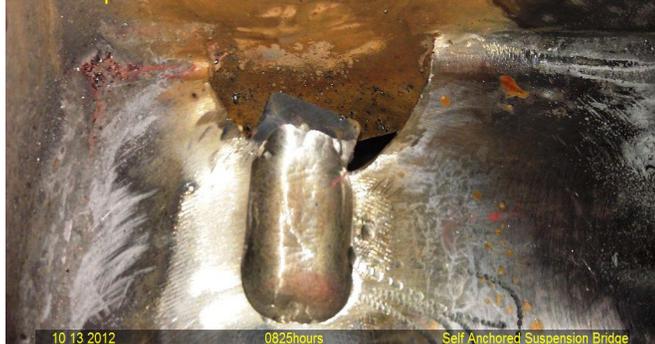
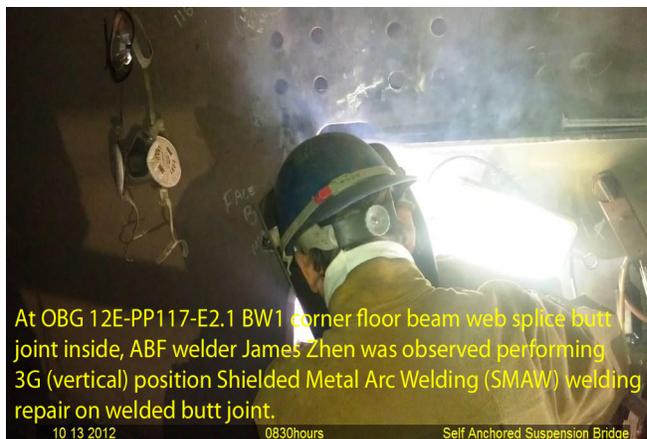
At OBG 12E-PP116-E2.1 PS2 corner drop-in floor beam plate stiffener splice joint inside, QA randomly observed ABF/JV qualified welder Lou Xiao Hua continuing to perform CJP groove welding second time repair on a non-Seismic Performance Critical Member (SPCM) due to Ultrasonic Testing (UT) detected defect on welded splice butt joint. The welder was noted using propylene gas torch to preheat the repair area and its vicinity to >150°F and as soon as the required temperature was attained the welder started performing the welding repair. Welder James Zhen was observed manually welding in 3G (vertical) position utilizing Shielded Metal Arc Welding (SMAW) with 3.2mm diameter E7018H4R electrode implementing Caltrans approved welding procedure ABF-WPS-D15-1000 Repair Rev. 2. During welding, ABF QC William Sherwood was noted monitoring the welder's welding parameter with measured working current of 130 amperes on the 3.2mm diameter E7018H4R electrodes. During the shift, repair welding at the location listed below were noted;

Y-location	Length	Width	Depth	Remarks
1. 15	50mm	25mm	6mm	R2 – completed.

At OBG 12E-PP116-E2.1 PS2 plate stiffener inside, excavation profile of the second time repair was noted 50mm long x 25mm wide x 6mm deep.
