DEPARTMENT OF TRANSPORTATION

Contract #: 04-0120F4Cty: SF/ALA Rte: 80 PM: 13.2/13.9File #: 1.28**WELDING INSPECTION REPORT****Resident Engineer:** Casey, William**Address:** 333 Burma Road**City:** Oakland, CA 94607**Report No:** WIR-028591**Date Inspected:** 13-Oct-2012**Project Name:** SAS Superstructure**OSM Arrival Time:** 700**Prime Contractor:** American Bridge/Fluor Enterprises, a JV**OSM Departure Time:** 1530**Contractor:** American Bridge/Fluor Enterprises, a JV**Location:** Jobsite**CWI Name:** William Sherwood**CWI Present:** Yes No**Inspected CWI report:** Yes No N/A**Rod Oven in Use:** Yes No N/A**Electrode to specification:** Yes No N/A**Weld Procedures Followed:** Yes No N/A**Qualified Welders:** Yes No N/A**Verified Joint Fit-up:** Yes No N/A**Approved Drawings:** Yes No N/A**Approved WPS:** Yes No N/A**Delayed / Cancelled:** Yes No N/A**Bridge No:** 34-0006**Component:** OBG 13 East**Summary of Items Observed:**

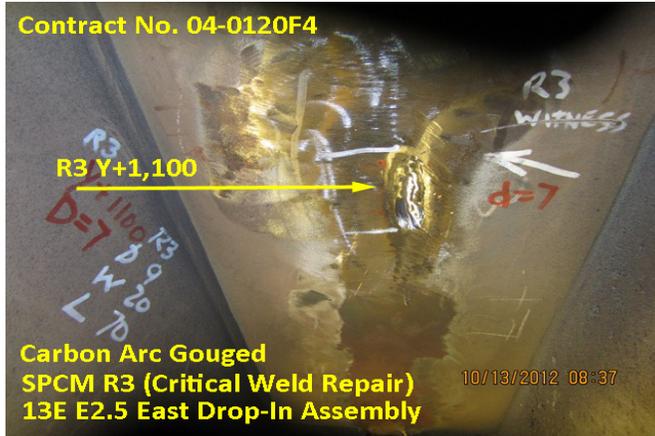
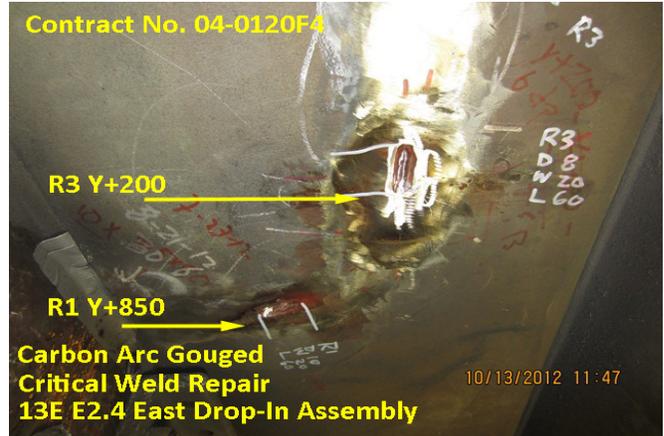
The QAI observed actual carbon arc gouging, excavation revealed (1) 15-mm planar discontinuity at the root face, approximately 4-mm deep.

The QAI observed actual carbon arc gouging, excavation revealed (1) 20-mm planar discontinuity at the root face, approximately 6-mm deep.

The QAI observed actual carbon arc gouging, excavation revealed (1) 21-mm planar discontinuity at the root face, approximately 7-mm deep.
