Contract #: 04-0120F4Cty: SF/ALA Rte: 80 PM: 13.2/13.9File #: 1.28**WELDING INSPECTION REPORT**

Report No: WIR-028601
Date Inspected: 16-Oct-2012

Project Name: SAS Superstructure
Prime Contractor: American Bridge/Fluor Enterprises, a JV
Contractor: American Bridge/Fluor Enterprises, a JV

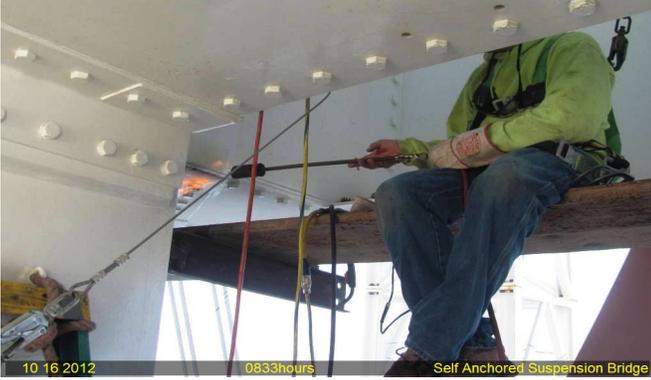
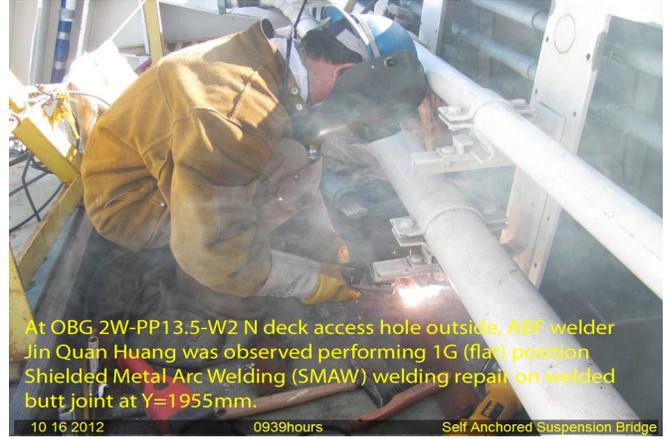
At Tower elevation 123 meter, ABF welder Richard Garcia was noted preheating the seal/bent plate prior FCAW-S welding.
