**DEPARTMENT OF TRANSPORTATION**

Contract #: 04-0120F4Cty: SF/ALA Rte: 80 PM: 13.2/13.9File #: 1.28**WELDING INSPECTION REPORT****Resident Engineer:** Casey, William**Address:** 333 Burma Road**City:** Oakland, CA 94607**Report No:** WIR-028613**Date Inspected:** 18-Oct-2012**Project Name:** SAS Superstructure**OSM Arrival Time:** 700**Prime Contractor:** American Bridge/Fluor Enterprises, a JV**OSM Departure Time:** 1730**Contractor:** American Bridge/Fluor Enterprises, a JV**Location:** Job Site**CWI Name:** Steve Jensen and Barry Drake**CWI Present:** Yes No**Inspected CWI report:** Yes No N/A**Rod Oven in Use:** Yes No N/A**Electrode to specification:** Yes No N/A**Weld Procedures Followed:** Yes No N/A**Qualified Welders:** Yes No N/A**Verified Joint Fit-up:** Yes No N/A**Approved Drawings:** Yes No N/A**Approved WPS:** Yes No N/A**Delayed / Cancelled:** Yes No N/A**Bridge No:** 34-0006**Component:** SAS OBG**Summary of Items Observed:**

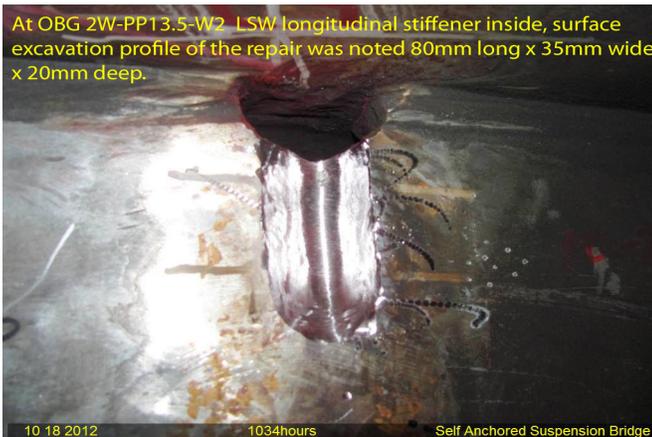
At OBG 2W-PP13.5-W2 LSW longitudinal stiffener inside, surface excavation profile of the repair was noted 80mm long x 35mm wide x 20mm deep.

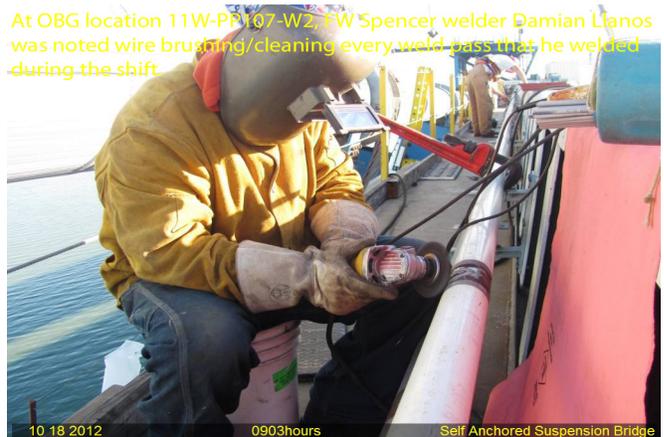
At OBG location 11W-PF107-W2, FW Spencer welder Damian Llanos was noted wire brushing/cleaning every weld pass that he welded during the shift.

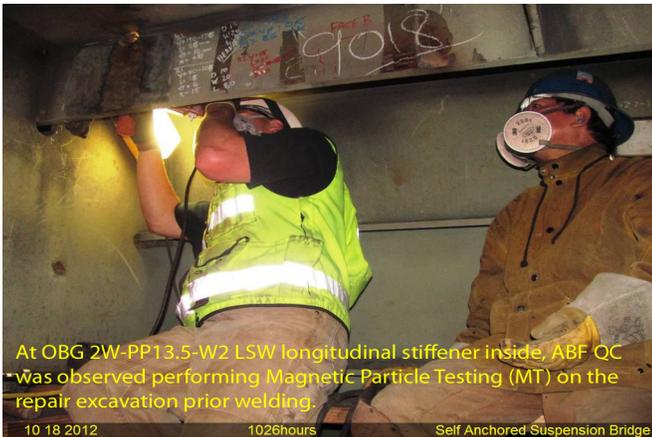
At OBG 2W-PP13.5-W2 LSW longitudinal stiffener inside, ABF QC was observed performing Magnetic Particle Testing (MT) on the repair excavation prior welding.

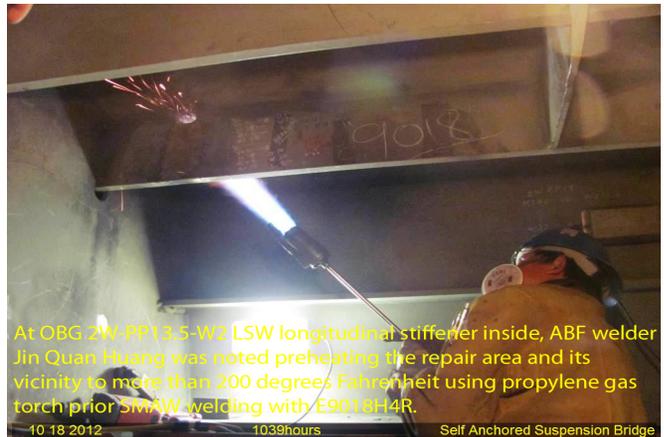
At OBG 2W-PP13.5-W2 LSW longitudinal stiffener inside, ABF welder Jin Quan Huang was noted preheating the repair area and its vicinity to more than 200 degrees Fahrenheit using propylene gas torch prior SMAW welding with E9018H4R.
