DEPARTMENT OF TRANSPORTATION

Contract #: 04-0120F4Cty: SF/ALA Rte: 80 PM: 13.2/13.9File #: 1.28**WELDING INSPECTION REPORT****Resident Engineer:** Casey, William**Address:** 333 Burma Road**City:** Oakland, CA 94607**Report No:** WIR-028615**Date Inspected:** 20-Oct-2012**Project Name:** SAS Superstructure**OSM Arrival Time:** 700**Prime Contractor:** American Bridge/Fluor Enterprises, a JV**OSM Departure Time:** 1530**Contractor:** American Bridge/Fluor Enterprises, a JV**Location:** Job Site

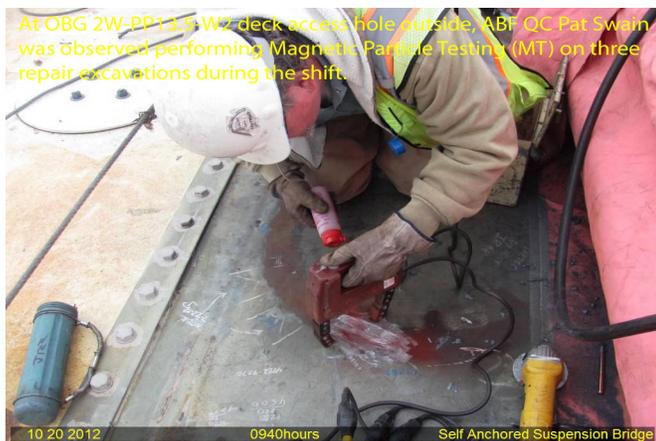
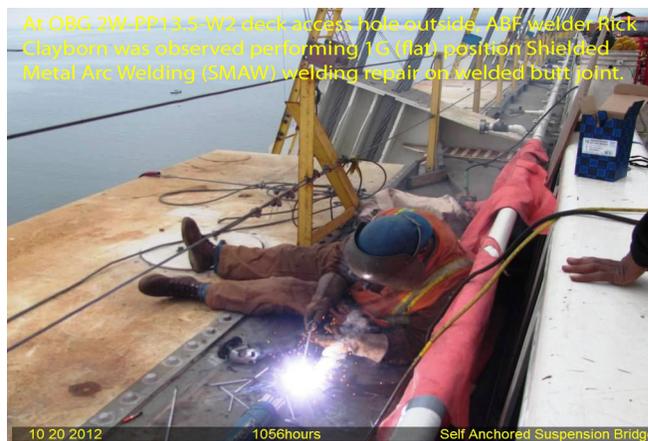
At OBG 2W-PP13.5-W2 N deck access hole inside, QA randomly observed ABF/JV qualified welder Ric Clayborn continuing to perform CJP groove welding repair due to UT detected defect and heat transfer mark using oxy-propylene gas torch. The welding repair is being performed on three (3) various locations per Caltrans approved Request for Weld Repair (RWR) # 201209-114 through 116. The welder was observed welding in the 1G (flat) position utilizing Shielded Metal Arc Welding (SMAW) with 3.2mm diameter E7018H4R electrode implementing welding procedure ABF-WPS-D15-1000-Repairs. The repair excavations were excavated using carbon air arc gouging with preheat temperature of more than 150°F using propylene gas torch prior excavation. The groove of the excavation was ground smooth and tested by ABF QC Salvador Merino using Magnetic Particle Testing (MT). During welding repair, the repair area and its vicinity was preheated to more than 150 degree Fahrenheit using propylene gas torch prior/during welding. During the shift, ABF QC Salvador Merino was noted monitoring the welder with measured working current of 170 amperes on 4.0mm E7018H4R electrode. At the end of the shift all three excavations from the top were completed. However, contractor's recommended WPS to be used (listed in the RWR) during welding repair were not implemented due to non-conformity to the joint configuration and this was brought to the attention of Lead QA Rodney Patterson. The following repairs were noted excavated and welded from the bottom during the shift;

1. 415mm 115mm 65mm 12mm 201209-114 Completed.
2. 1195mm 135mm 60mm 11mm 201209-115 Completed.
3. 3365mm 150mm 70mm 11mm 201209-116 Completed.
