**DEPARTMENT OF TRANSPORTATION**

Contract #: 04-0120F4Cty: SF/ALA Rte: 80 PM: 13.2/13.9File #: 1.28**WELDING INSPECTION REPORT****Resident Engineer:** Casey, William**Address:** 333 Burma Road**City:** Oakland, CA 94607**Report No:** WIR-028636**Date Inspected:** 22-Oct-2012**Project Name:** SAS Superstructure**OSM Arrival Time:** 700**Prime Contractor:** American Bridge/Fluor Enterprises, a JV**OSM Departure Time:** 1530**Contractor:** American Bridge/Fluor Enterprises, a JV**Location:** Job site**CWI Name:** Salvador Moreno**CWI Present:** Yes No**Inspected CWI report:** Yes No N/A**Rod Oven in Use:** Yes No N/A**Electrode to specification:** Yes No N/A**Weld Procedures Followed:** Yes No N/A**Qualified Welders:** Yes No N/A**Verified Joint Fit-up:** Yes No N/A**Approved Drawings:** Yes No N/A**Approved WPS:** Yes No N/A**Delayed / Cancelled:** Yes No N/A**Bridge No:** 34-0006**Component:** OBG**Summary of Items Observed:**

13W Deck Access Hole Splice (Weld No. DAH-13W-PP124.5-W5)

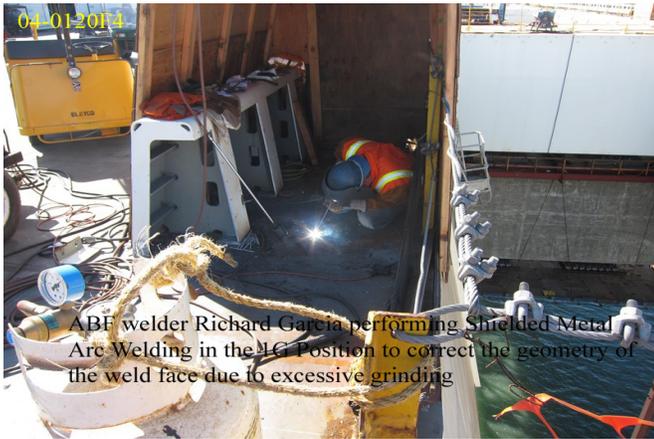
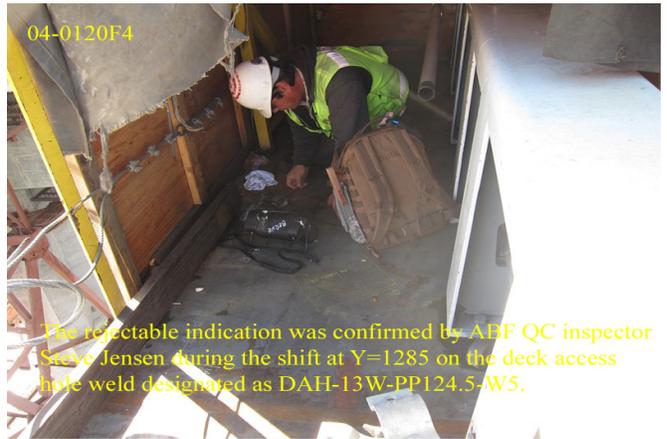
Y=1285 A total of one (1) rejectable indication was observed at the time of inspection. The rejectable indication was confirmed by ABF QC inspector Patrick Swain and Steve Jensen during the shift.

(SMAW) utilizing the Caltrans approved Welding Procedure Specifications ABF-WPS-D1.5-1004-Repair in the 1G position on the Deck access hole at panel point 124.5 at E5. The weld and surrounding area was brought to a temperature of 325°F by the use of a gas torch and was confirmed by ABF QC Salvador Moreno prior to welding. The repairs made at this location were to correct the geometry of the weld face due to excessive grinding. A post weld heat treatment was not required by the welding procedure used as only geometry of the weld face was corrected.
