DEPARTMENT OF TRANSPORTATION

Contract #: 04-0120F4Cty: SF/ALA Rte: 80 PM: 13.2/13.9File #: 1.28**WELDING INSPECTION REPORT****Resident Engineer:** Casey, William**Address:** 333 Burma Road**City:** Oakland, CA 94607**Report No:** WIR-028644**Date Inspected:** 22-Oct-2012**Project Name:** SAS Superstructure**OSM Arrival Time:** 700**Prime Contractor:** American Bridge/Fluor Enterprises, a JV**OSM Departure Time:** 1530**Contractor:** American Bridge/Fluor Enterprises, a JV**Location:** Job Site

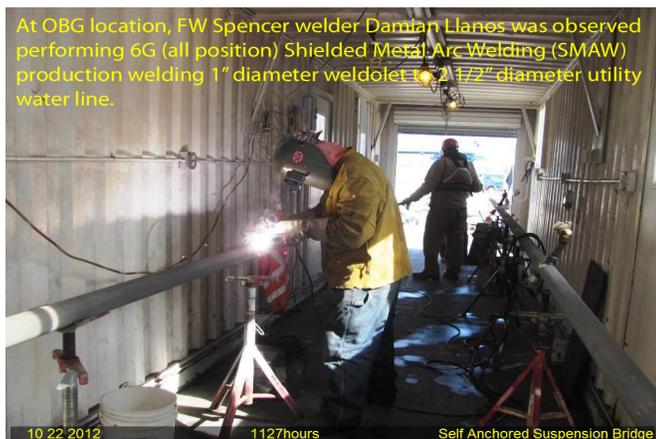
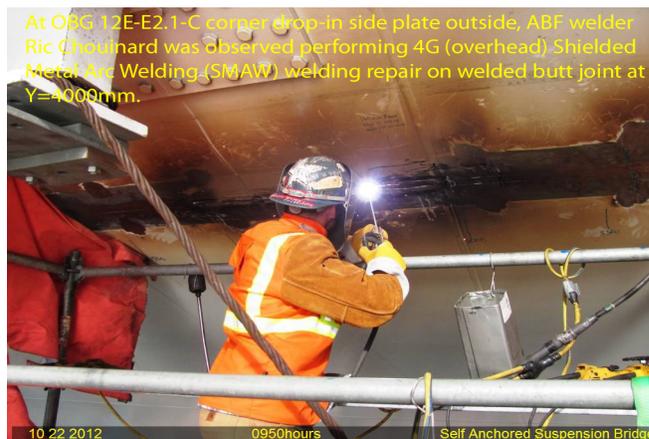
At OBG location Panel Point PP13.5 through PP16.5 Bikepath, this QA randomly observed FW Spencer qualified welder Damian Llanos continuing to perform Complete Joint Penetration (CJP) 6G (all position) Shielded Metal Arc Welding (SMAW) welding root pass to cover pass on 1" diameter weldolet to 2 1/2" diameter domestic utility water line. The welder was noted welding the root pass with 3/32" diameter E6010 electrode and followed by fill pass to cover pass using 3/32" diameter E7018H4R electrode implementing Caltrans approved procedure FW Spencer WPS 1-12-1. The welder was noted preheating and removing the moisture of the joint using a portable propane gas torch prior welding. During welding, ABF QC Steve Jensen was noted monitoring the parameters of the welder. At the end of the FW Spencer shift, CJP welding on four (4) 1" weldolet to 2 1/2" diameter utility water line was completed.
