DEPARTMENT OF TRANSPORTATION

Contract #: 04-0120F4Cty: SF/ALA Rte: 80 PM: 13.2/13.9File #: 1.28**WELDING INSPECTION REPORT****Resident Engineer:** Casey, William**Address:** 333 Burma Road**City:** Oakland, CA 94607**Report No:** WIR-028690**Date Inspected:** 29-Oct-2012**Project Name:** SAS Superstructure**OSM Arrival Time:** 700**Prime Contractor:** American Bridge/Fluor Enterprises, a JV**OSM Departure Time:** 1730**Contractor:** American Bridge/Fluor Enterprises, a JV**Location:** Job Site

| Bridge No: | 34-0006 | | | Component: | SAS OBG | | |

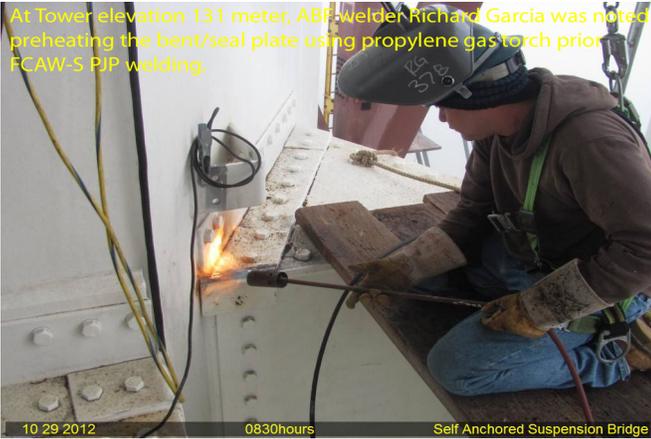
10 29 2012 0830hours Self Anchored Suspension Bridge

At Tower elevation 131 meter, ABF welder Richard Garcia was noted preheating the bent/seal plate using propylene gas torch prior FCAW S PIP welding.

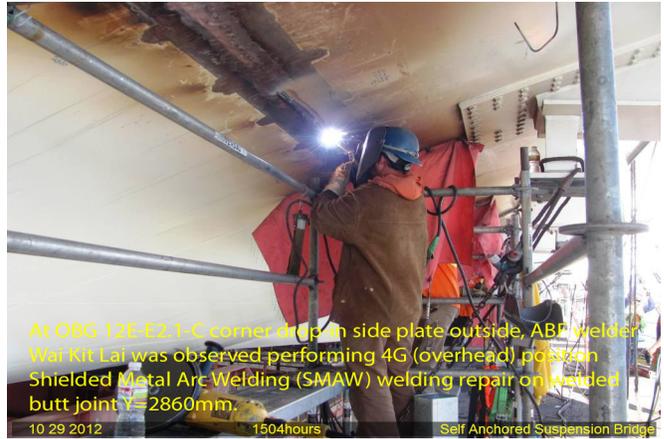
10 29 2012 1504hours Self Anchored Suspension Bridge

At OBG 12E-E2.1-C corner drop-in side plate outside, QA randomly observed ABF/JV qualified welder Wai Kit Lai continuing to perform CJP groove welding repair at location Y=2860mm to Y=38860mm with excavation profile of 1000mm long x 50mm wide x 11mm deep. The repair welding is being performed per Caltrans approved Request for Weld Repair (RWR) #201210-013. The welder was observed manually welding in the 4G (overhead)

At OBG 12E-E2.1-C corner drop in side plate outside, ABF welder Wai Kit Lai was observed performing 4G (overhead) position Shielded Metal Arc Welding (SMAW) welding repair on welded butt joint L= 2860mm.

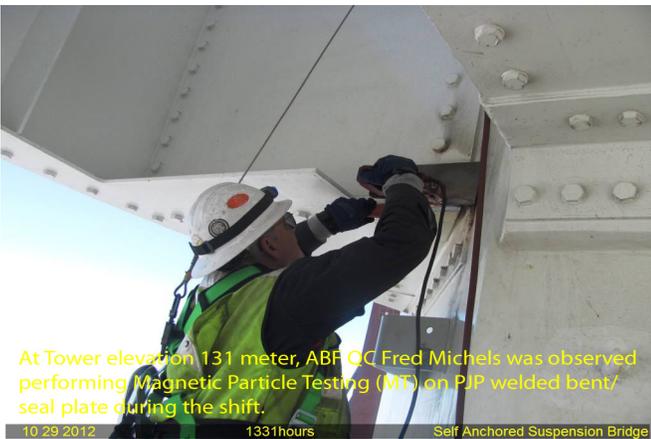
10 29 2012 1331hours Self Anchored Suspension Bridge

At Tower elevation 131 meter, ABF QC Fred Michels was observed performing Magnetic Particle Testing (MT) on PIP welded bent/seal plate during the shift.

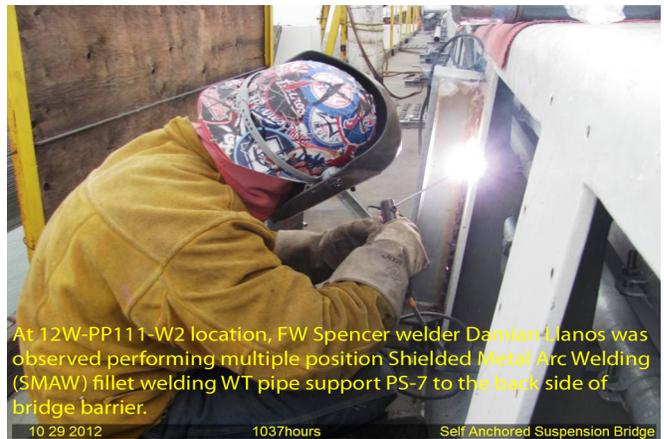
10 29 2012 1037hours Self Anchored Suspension Bridge

The QAI observe the ongoing installation, field fit-up and tack welding of the utility pipe support PS-7 (WT 4 ½" x 24" long) along the W2 grid line (panel point PP111). The pre-fabricated PS-7 WT utility support was fillet welded all around to the bridge barrier. The QC inspection was performed by Steve Jensen utilizing the Welding Procedure Specification (WPS) identified as Fillet Murex to monitor the tack welding and fillet welding to verify the welding parameters. The welding parameters were observed and recorded as 90 amps utilizing 2.4 mm electrodes with the welding performed in the 2F, 3F and 4F positions. The tack welding/fillet welding was performed by FW Spenser welder Damian Llanos.

At 12W-PP111-W2 location, FW Spencer welder Damian Lianos was observed performing multiple position Shielded Metal Arc Welding (SMAW) fillet welding WT pipe support PS-7 to the back side of bridge barrier.
