DEPARTMENT OF TRANSPORTATION

Contract #: 04-0120F4Cty: SF/ALA Rte: 80 PM: 13.2/13.9File #: 1.28**WELDING INSPECTION REPORT****Resident Engineer:** Casey, William**Address:** 333 Burma Road**City:** Oakland, CA 94607**Report No:** WIR-028694**Date Inspected:** 20-Oct-2012**Project Name:** SAS Superstructure**OSM Arrival Time:** 700**Prime Contractor:** American Bridge/Fluor Enterprises, a JV**OSM Departure Time:** 1530**Contractor:** American Bridge/Fluor Enterprises, a JV**Location:** Job Site**CWI Name:** See below.**CWI Present:** Yes No**Inspected CWI report:** Yes No N/A**Rod Oven in Use:** Yes No N/A**Electrode to specification:** Yes No N/A**Weld Procedures Followed:** Yes No N/A**Qualified Welders:** Yes No N/A**Verified Joint Fit-up:** Yes No N/A**Approved Drawings:** Yes No N/A**Approved WPS:** Yes No N/A**Delayed / Cancelled:** Yes No N/A**Bridge No:** 34-0006**Component:** OBG**Summary of Items Observed:**

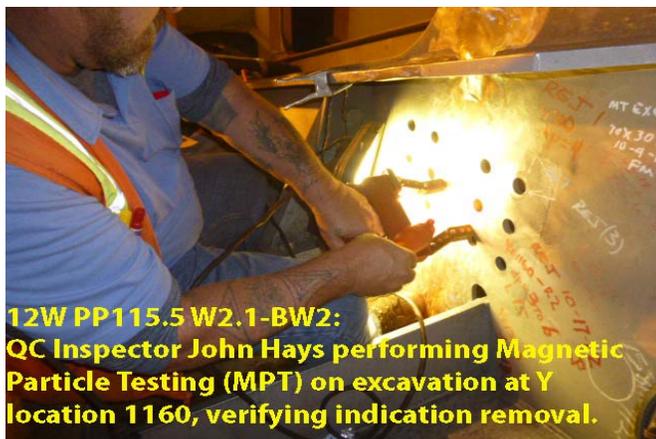
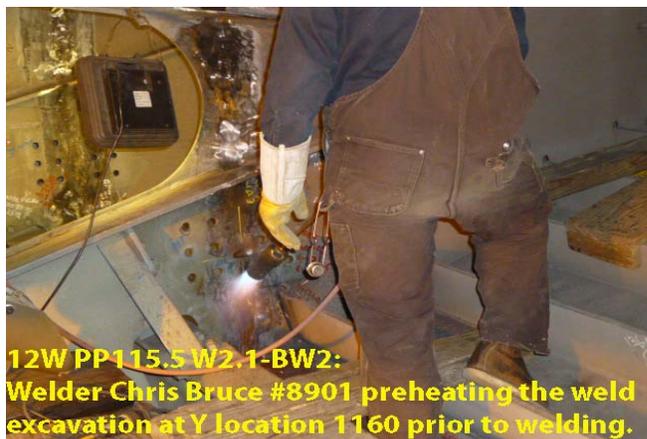
Welder was observed performing weld repairs on welds 12W W2.1-A1 and 12W PP115.5 W2.1-BW2, on Ultrasonic Testing Shear Wave (UTSW) rejected indications noted by QC Inspectors. Welder was observed utilizing Welding Procedure Specification (WPS) ABF-WPS-D15-1004R for Shielded Metal Arc Welding (SMAW). The welder was observed preheating the welds prior to Carbon Arc Gouging and welding. Other welding parameters as inspected by QC Inspector John Hays appear to be in compliance with the WPS noted above.

- Deck Access Hole QA 50% Verification (2180mm x 20mm Thick, VT Reject)

- Weld BW2 - Repair Excavation (64 x 30 x 7 Deep, MPT Accept.)

This QA informed QC Inspector Salvador Merino of unacceptable indications on weld 13E PP124.5 E2.1-DAH Face A
