DEPARTMENT OF TRANSPORTATION

Contract #: 04-0120F4Cty: SF/ALA Rte: 80 PM: 13.2/13.9File #: 1.28**WELDING INSPECTION REPORT****Resident Engineer:** Casey, William**Address:** 333 Burma Road**City:** Oakland, CA 94607**Report No:** WIR-028701**Date Inspected:** 31-Oct-2012**Project Name:** SAS Superstructure**OSM Arrival Time:** 700**Prime Contractor:** American Bridge/Fluor Enterprises, a JV**OSM Departure Time:** 1730**Contractor:** American Bridge/Fluor Enterprises, a JV**Location:** Job site

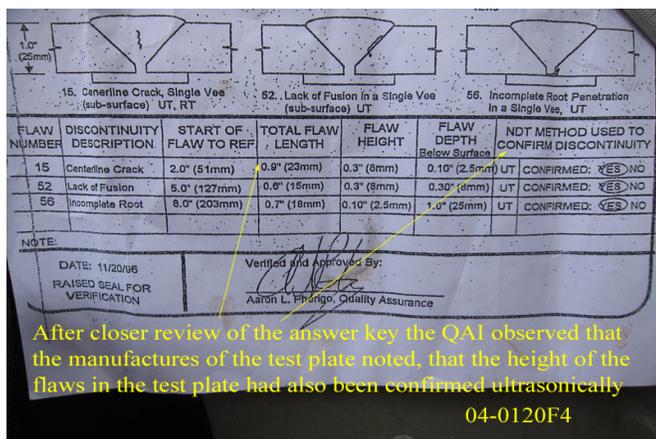
The QAI was assigned by the QA Task Leader to the to perform Ultrasonic verification of planar indications height in the weld from the ABF QC and QA joint reports on the Tower Electro Slag butt weld designated as ESW "V". Upon arrival to the site the QAI observed ABF QC inspector Andrew Keach, Jesse Cayabyab as well as the ABF QC lead Lenard Cross. During discussions with the ABF QC lead Lenard Cross it was explained to the QAI that ABF QC would be performing exploratory ultrasonic testing to determine the validity a 6db drop technique for the determination of height on the linear recordable indications for the ESW welds. The height of the indications in the welds would then be confirmed by excavation of the weld. The ABF QC inspectors were then observed performing exploratory Ultrasonic testing with 2.25 MHz 45 and 70 degree AWS transducers as well as a 2.25 MHz, .25" mini transducer on the ESW Weld designated as ESW "V".
